North Devon Estuary Project

The application of agricultural wetlands to improve water quality and benefit biodiversity

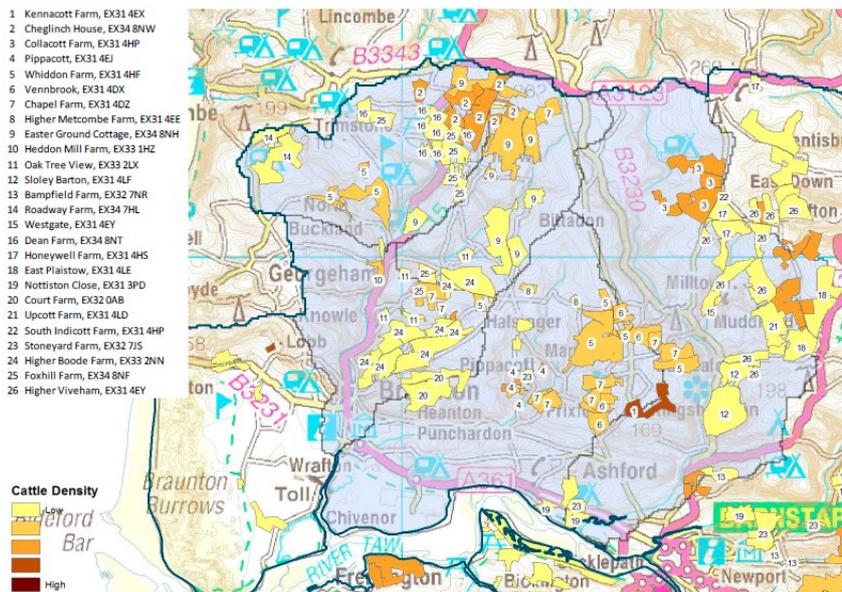
Map of the target project area including the farms with the highest cattle density

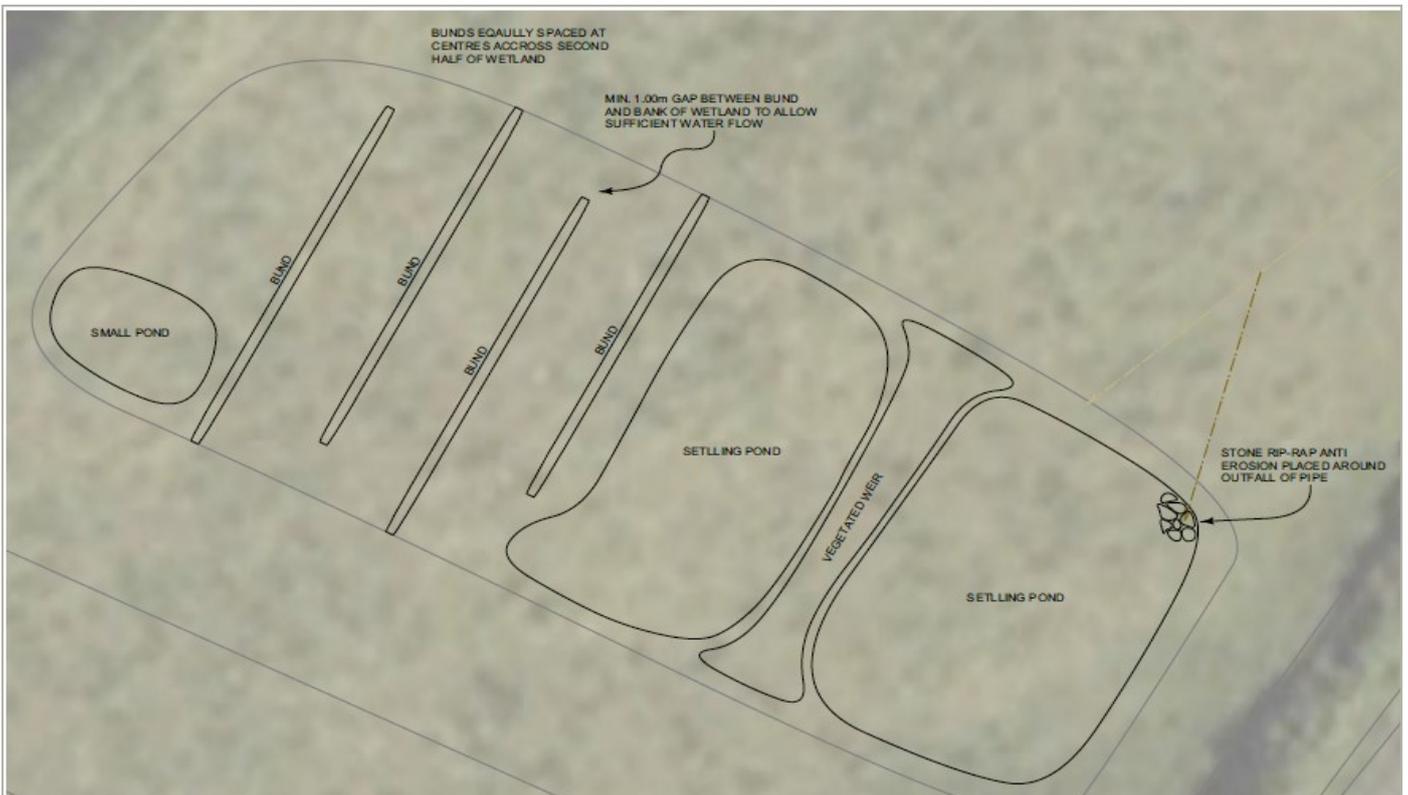
Plan for treatment cell 1, design by WWT consulting, approx. 50m length

This farm had a 3-cell treatment wetland system ending in a final polishing channel. A mixture of clean and dirty water was entering the system, overloading it with nutrients. Following advice from the Environment Agency and Catchment Sensitive Farming, appropriate infrastructure was put in place to separate clean and dirty water with only roof, yard and track water now entering the wetland. The first treatment cell was redesigned by WWT to help with sediment removal and reduce nutrient loading. Before the redesign, the cell was emptied fully, removing any heavily loaded sediment.

The re-design of cell one included two deep sections acting as settling ponds and helping to remove phosphate. There is a weir planted with yellow flag iris between the two deep sections to increase biological and UV activity, both of which improve water quality. The next section is a series of bunds to increase the hydraulic pathway, ending in a deep pond that flows into the next two treatment cells. These cells and the polishing channel have not been altered. They also act to slow the water and reduce nutrient loading even further.

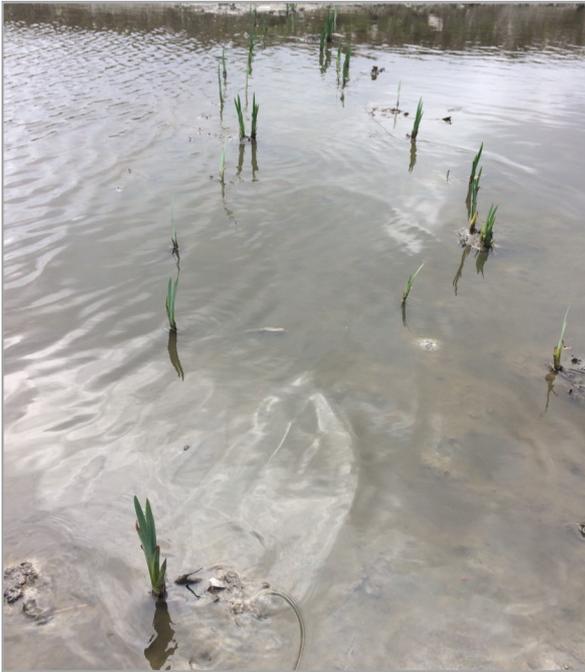
Yellow flag iris bund

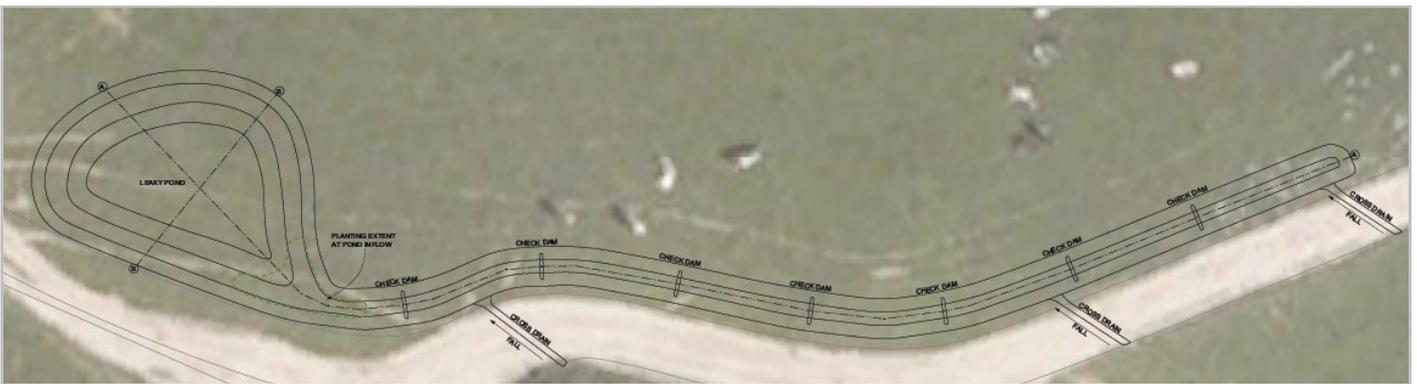
Baffle ditch and leaky pond design by WWT

The principle aim was to divert water into a baffle ditch system and then into a leaky pond away from the farmyard. The baffle ditch will slow the water down, and the leaky pond will allow the water to gradually drain away.

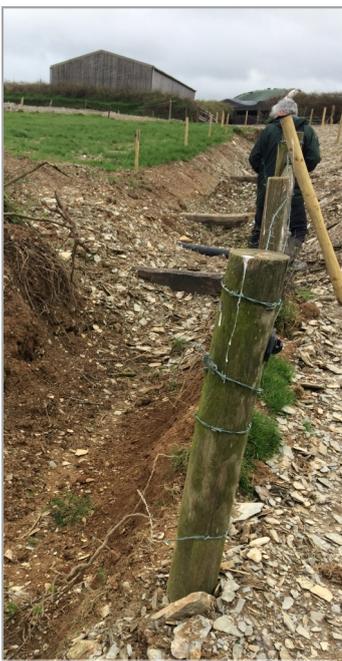
Baffle ditch

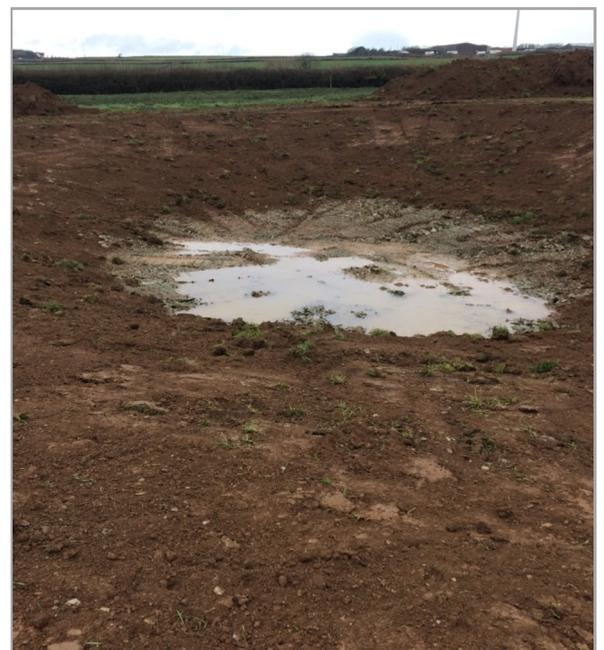
Leaky pond, to which the baffle ditch leads

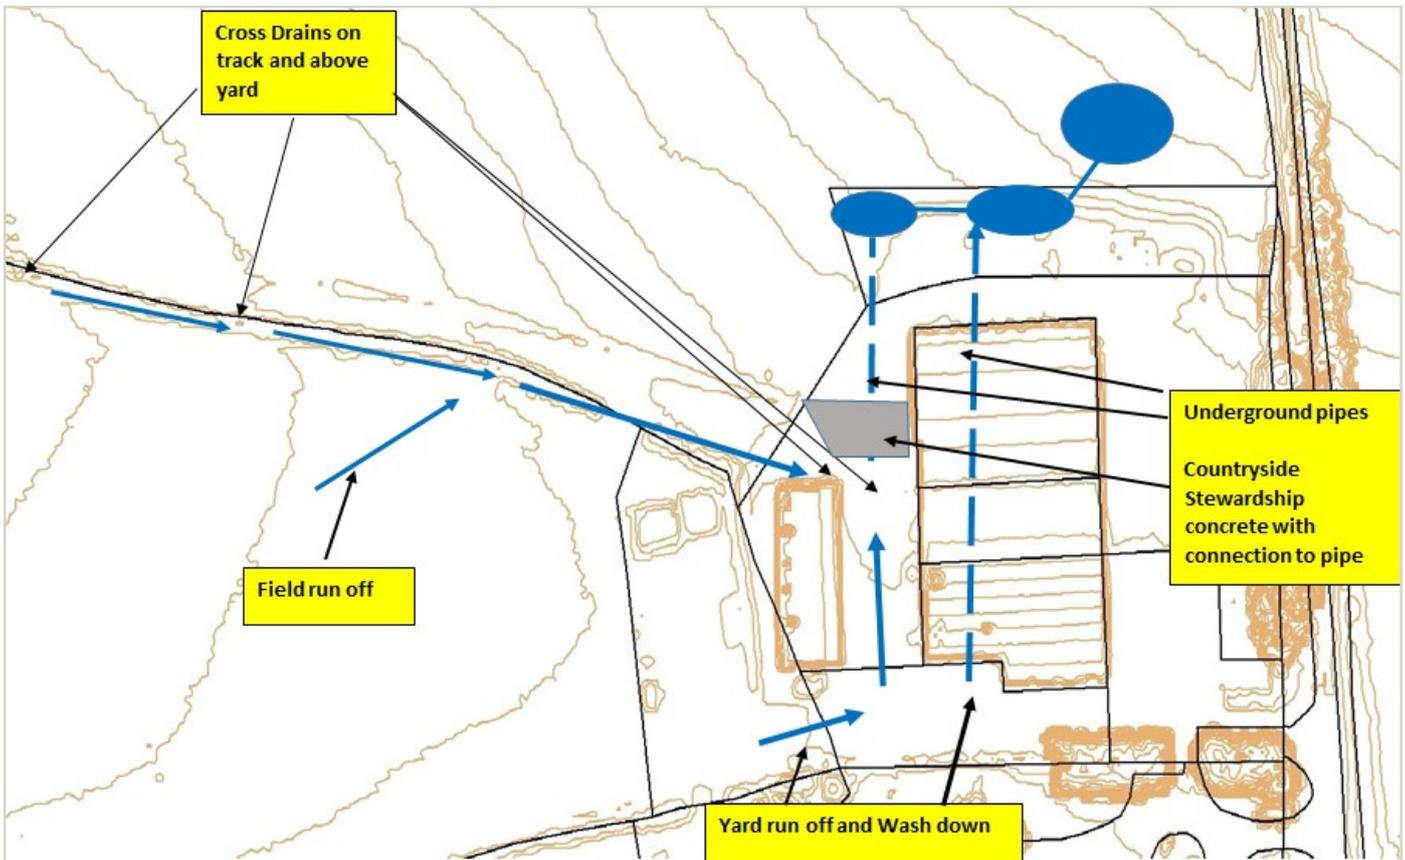
The cross drain effectively takes water off the track which helps prevent it from becoming fouled. This measure, as well as cross drains on other tracks, are really simple, inexpensive solutions for farmers.

The design by Westcountry Rivers Trust aimed to channel water from the track using cross drains connected to soakaways in the field. A final cross drain diverts water from the holding pen, and will channel it into the first of three settlement ponds. Soil compaction advice was given to reduce field runoff. Yard runoff and water from the wash down area are also piped to the settlement ponds. The three ponds allow sediment to settle, reduce nutrient loading, and attenuate water.

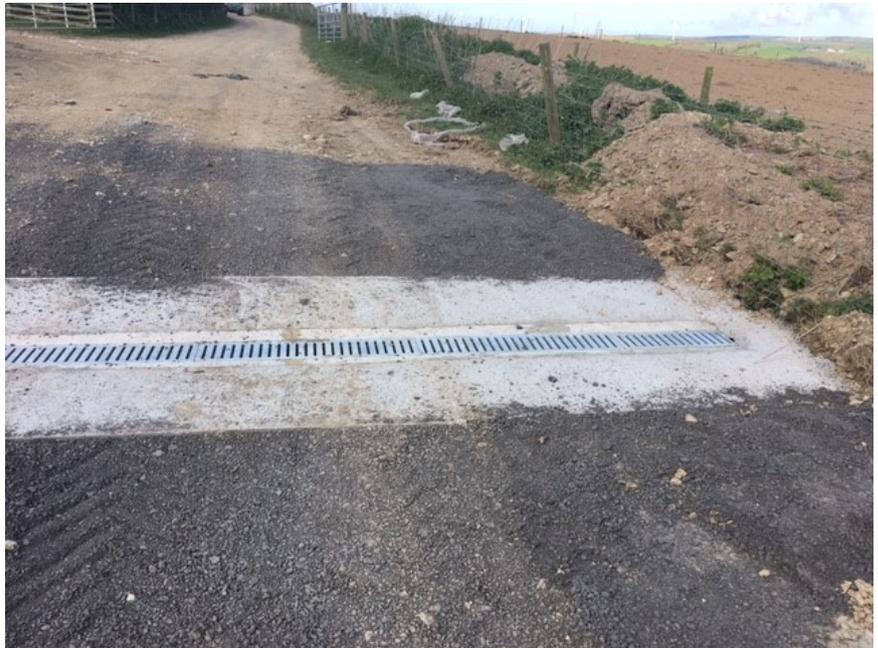
The cross drain at the bottom of the track. Water is piped from this into the ponds.

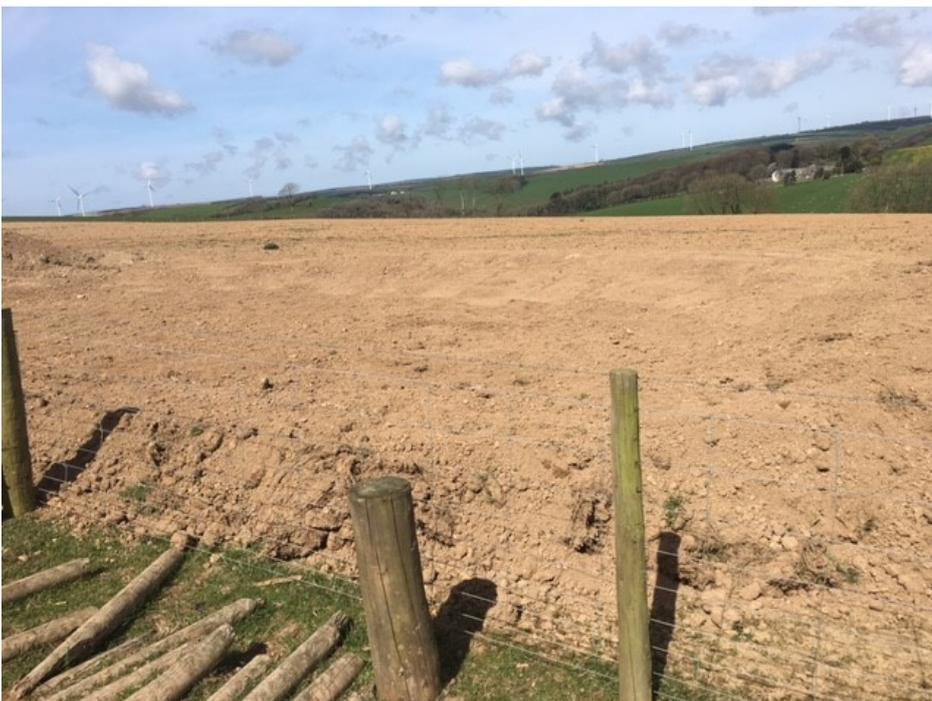
One of the ponds mid-construction

Each pond had a deeper section to allow sediment dropout, and the shallower sections will vegetate over time which is important for wildlife.

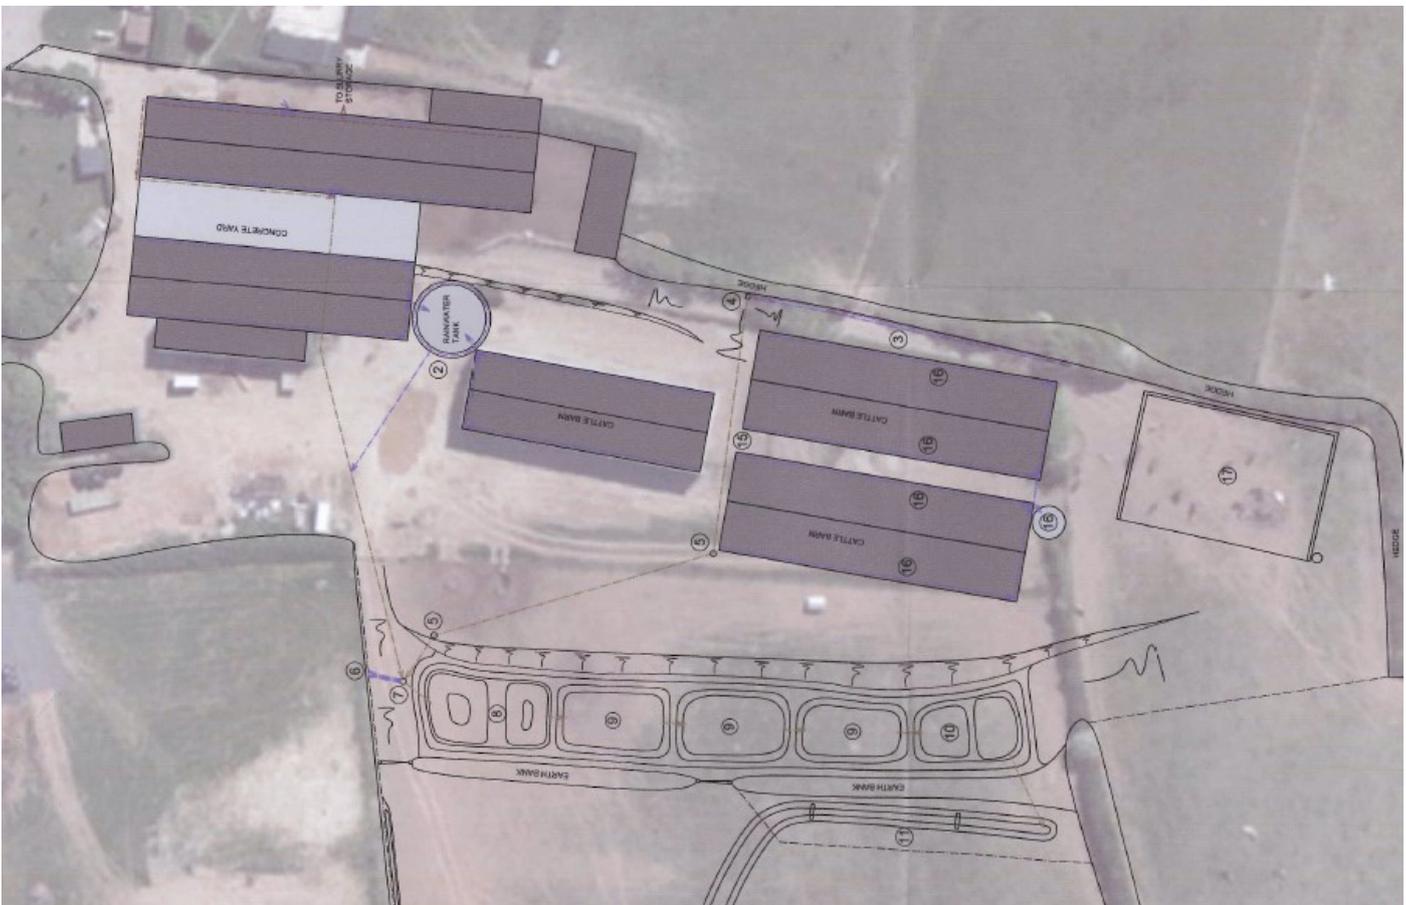
The reeds increase water residency time, allowing UV to break down harmful bacteria.

The design by WWT included a raised bump at the entrance of the farm to stop water entering from the road, and a cross drain across the track leading into the wetland ponds. There are 5 ponds of varying depths. The first is 2 metres deep and designed to help sediment to drop out of the water. It is connected to the next via a vegetated weir. The subsequent three ponds are shallower, to again remove sediment, and they all include reeds.

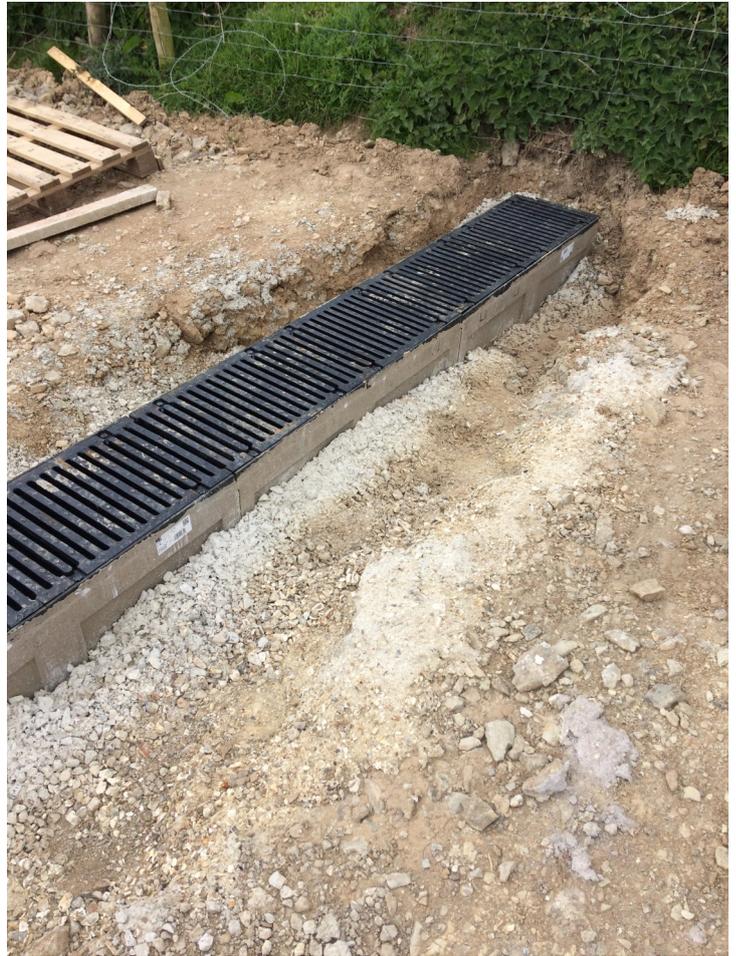
Track cross drain in construction, designed to take heavy machinery

The cross drain has inspection chambers installed for easy maintenance. Very important on a busy farm.

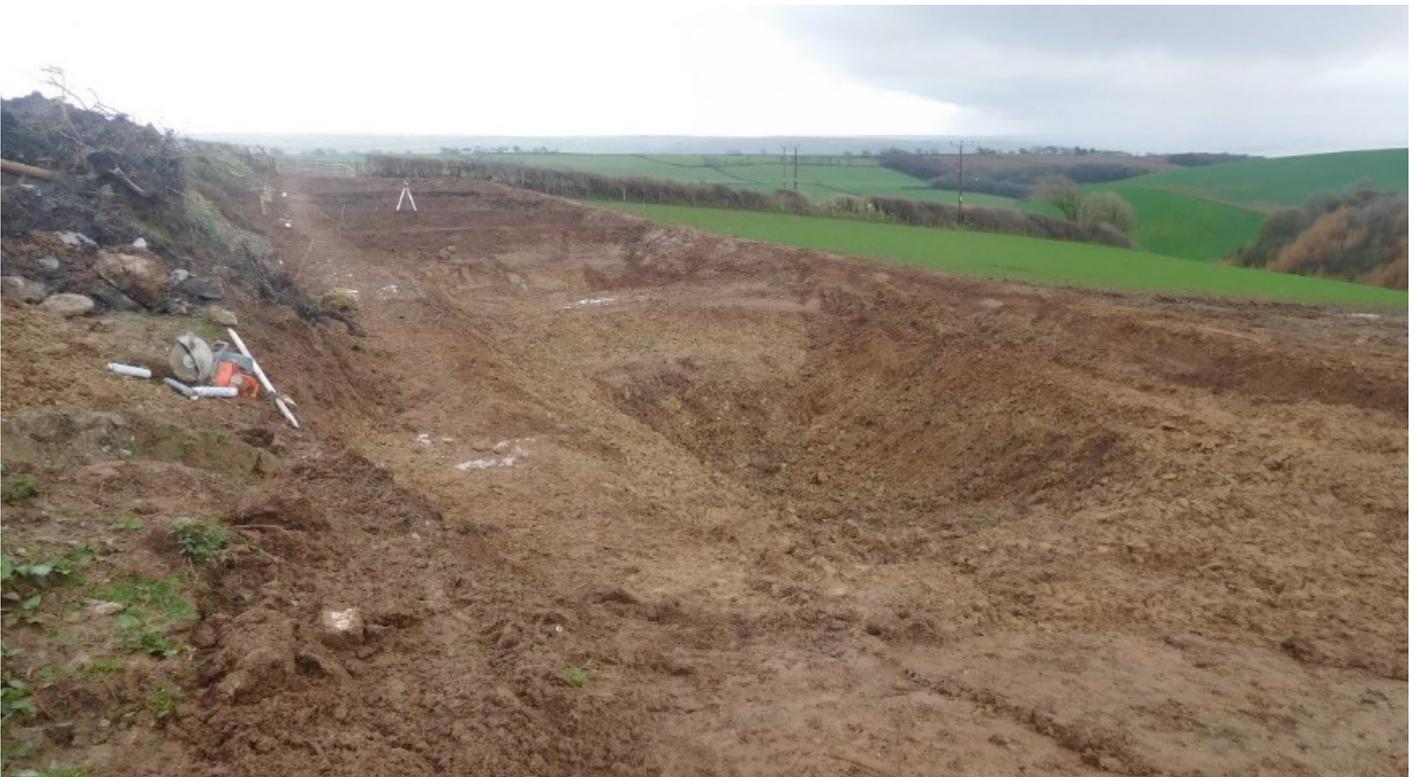
The 5 ponds mid-construction. Getting the levels right was a feat in itself.
