# Braunton Marsh

MANAGEMENT STUDY 2007

By Clare Manning BSc (Hons)

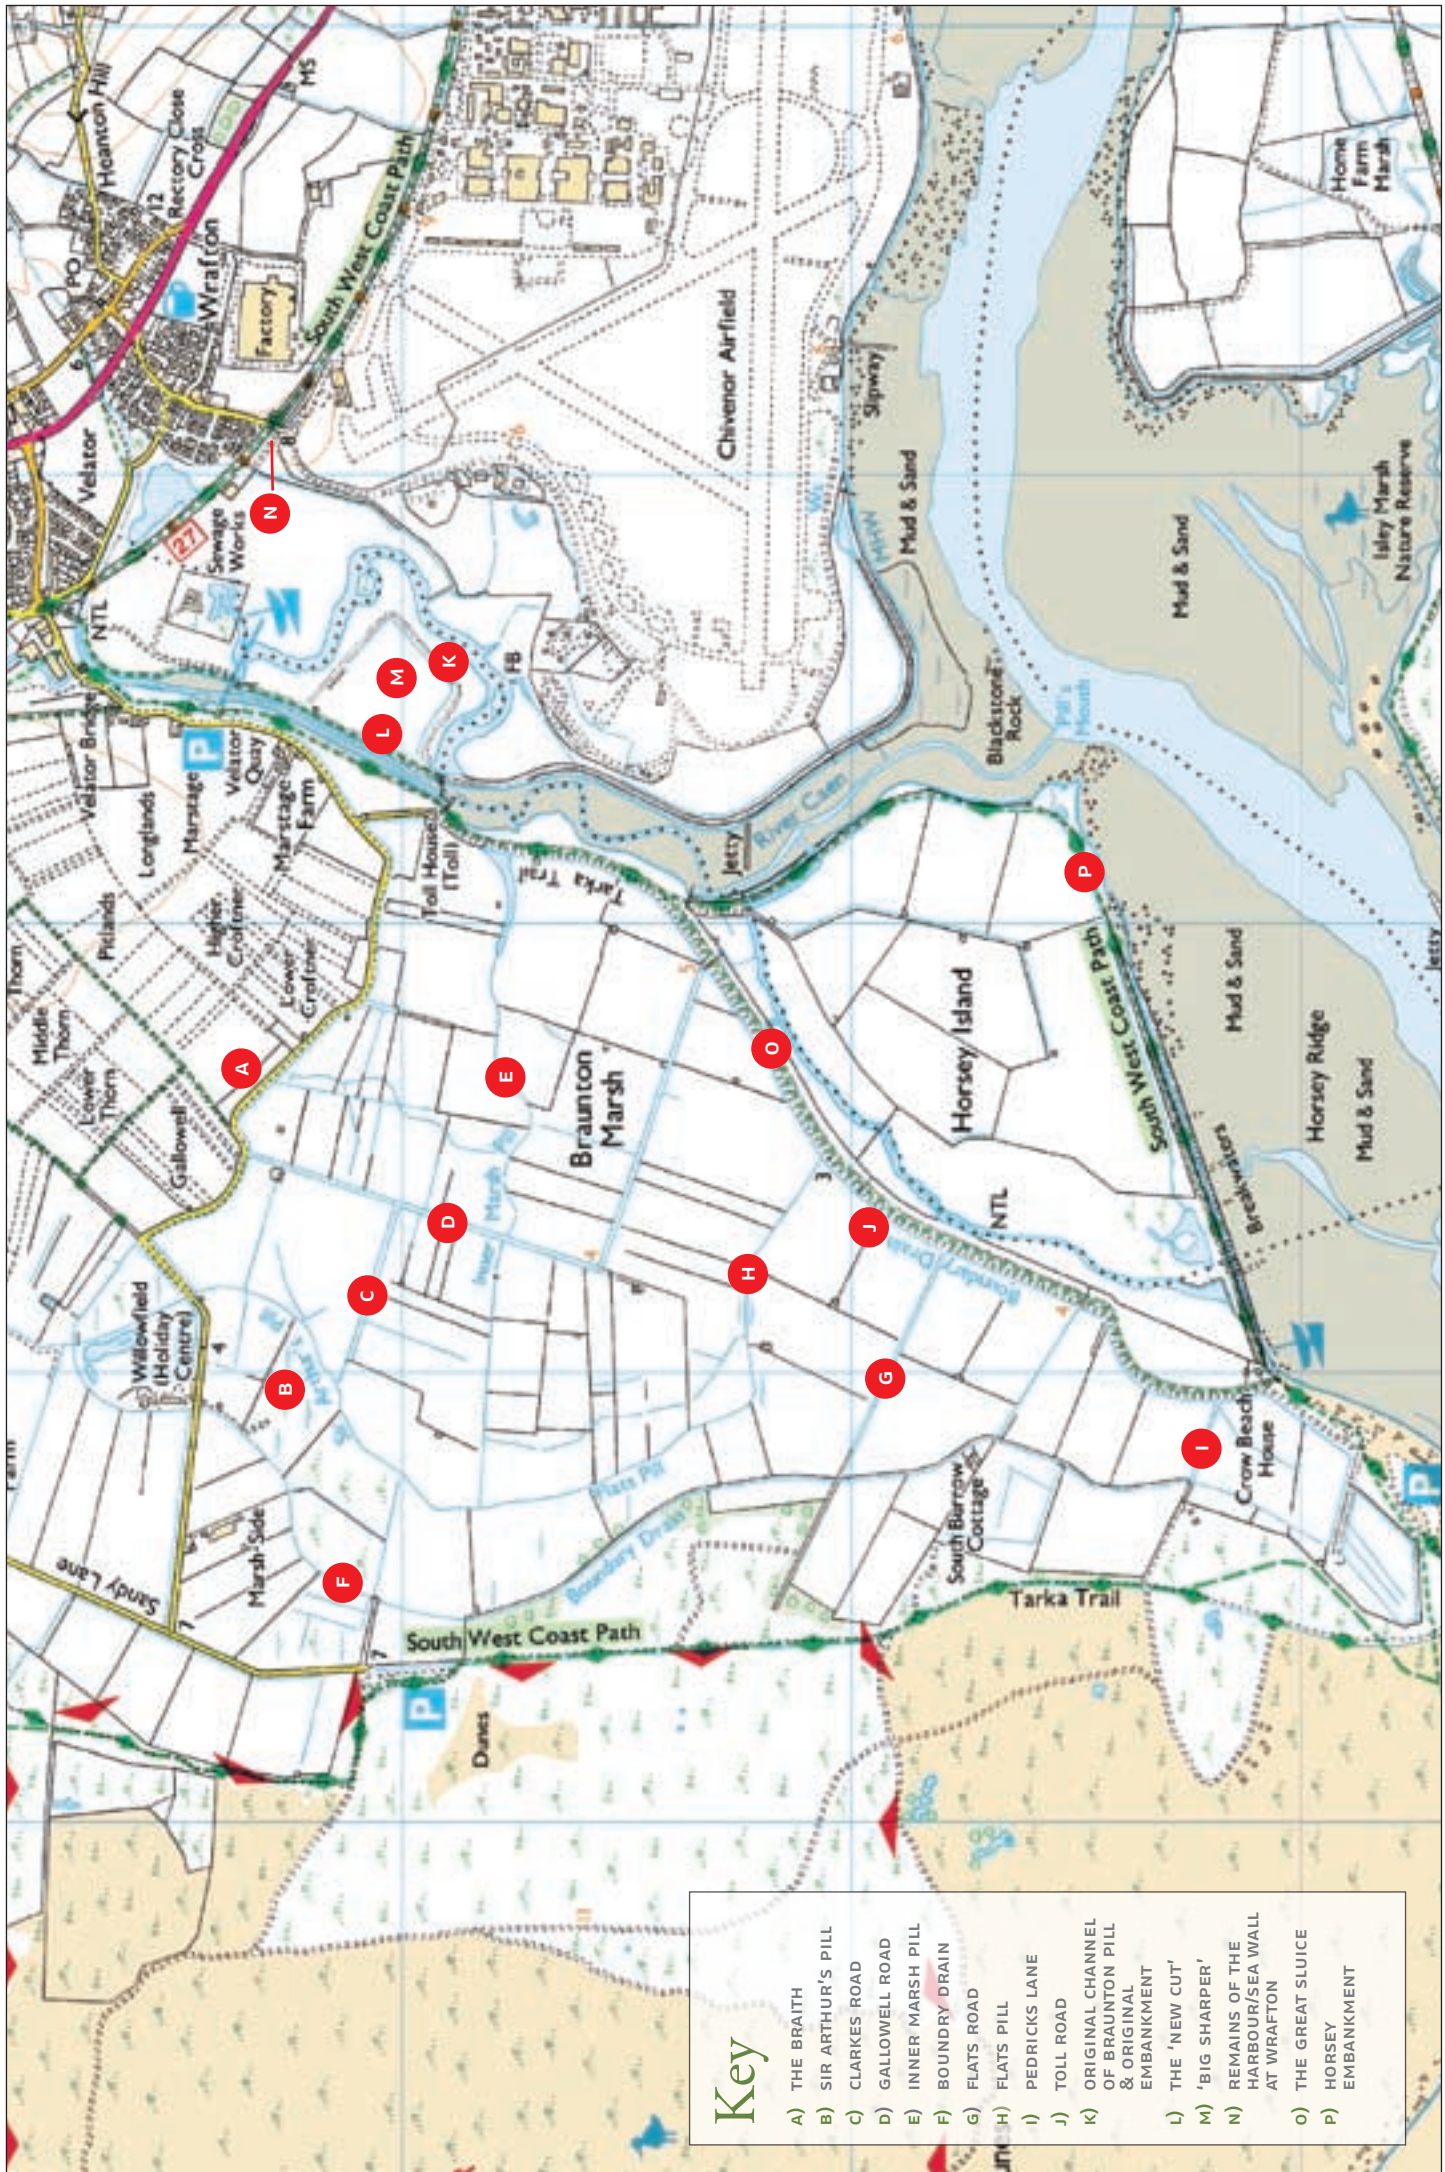
Key	
A)	THE BRAITH
B)	SIR ARTHUR'S PILL
C)	CLARKES ROAD
D)	GALLOWELL ROAD
E)	INNER MARSH PILL
F)	BOUNDRY DRAIN
G)	FLATS ROAD
H)	FLATS PILL
I)	PEDRICKS LANE
J)	TOLL ROAD
K)	ORIGINAL CHANNEL OF BRAUNTON PILL & ORIGINAL EMBANKMENT
L)	THE 'NEW CUT'
M)	'BIG SHARPER'
N)	REMAINS OF THE HARBOUR/SEA WALL AT WRAFTON
O)	THE GREAT SLUICE
P)	HORSEY EMBANKMENT

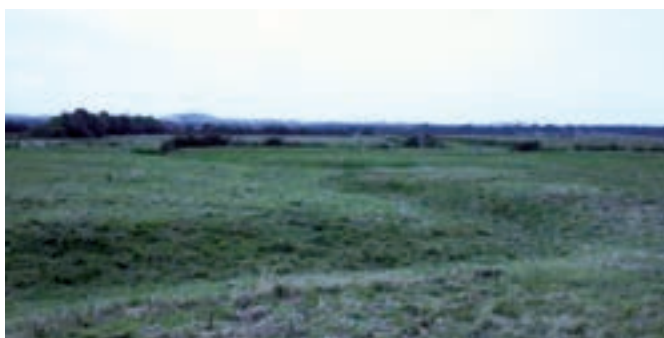
FIG 1. RELIC TIDAL GUTS ARE EVIDENT ACROSS THE BRAUNTON MARSHES

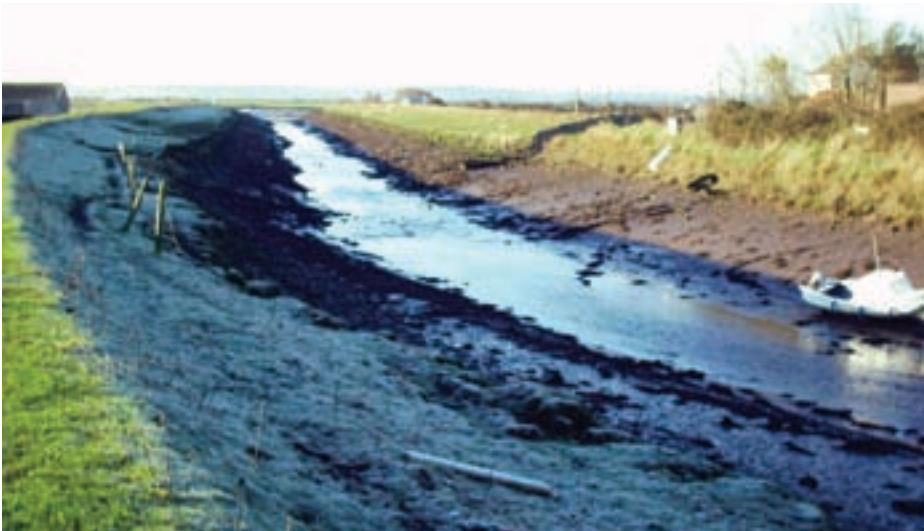
THE STRAIGHTENED SECTION OF THE BRAUNTON PILL, ALSO KNOWN AS THE 'NEW CUT'

In January 1853, the Williams' Estate revealed an ambitious plan for further reclamation of tidal lands of both Velator and Wrafton Marsh, to include the straightening of the Braunton Pill. Despite the misgivings of the engineer, Nicholas Whitley, the enclosure of 'a barren patch of sand' at Horsey Island was also undertaken. The details of this important phase of the development and diversification of the area surrounding, and influencing, the Braunton Marsh, are contained in Appendix 6. Details include the significant difficulties encountered by the construction of embankments on areas of quicksand, the structure of the banks, the necessity for land drainage, agreements with the Marsh Inspectors, and the overall cost, which totalled around £18,000 (calculated as equivalent to £1,110,958.38 against the 2005 Retail Price Index<sup>2</sup>). The reclamation and the straightening of the Pill were completed in 1857.

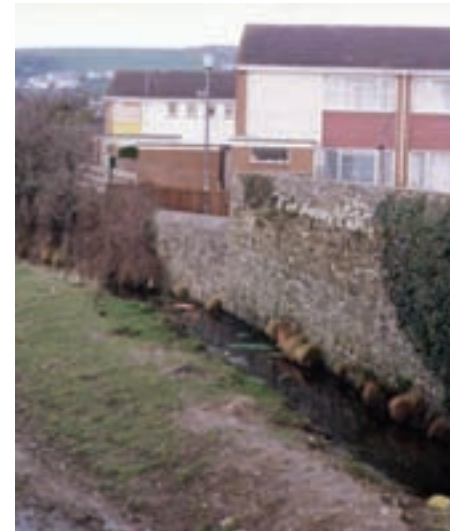
THE OLD SEA WALL AT WRAFTON

After the first reclamation, the main quay was at Wrafton. The remains of a sea or harbour wall is positioned to the west of the railway underpass (now the Tarka Trail) on the western edge of the village. Until a few years ago, it is reported that the metal hooks for boat moorings could still be seen<sup>1</sup>. The route to the original pill followed a winding channel, and was of insufficient depth for larger vessels. The records suggest a long-standing desire to develop a new quay along the Braunton Pill, which would be capable of mooring larger vessels. Despite the efforts made by the Marsh Inspectors to pursue this goal in the early 1840s, the development of the new quay at Braunton was not destined to occur until after the Heanton Estate was sold to the Williams family around 1850.

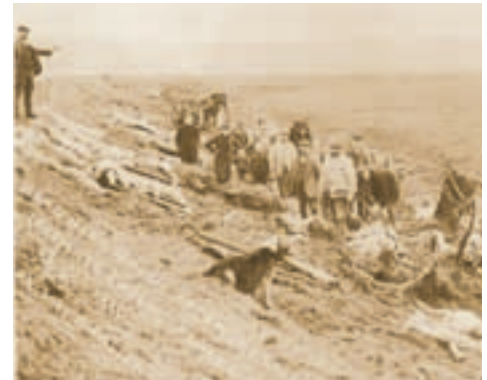
'BRAUNTON MARSH AFTER THE GALE - (DROWNED SHEEP)<sup>4</sup>

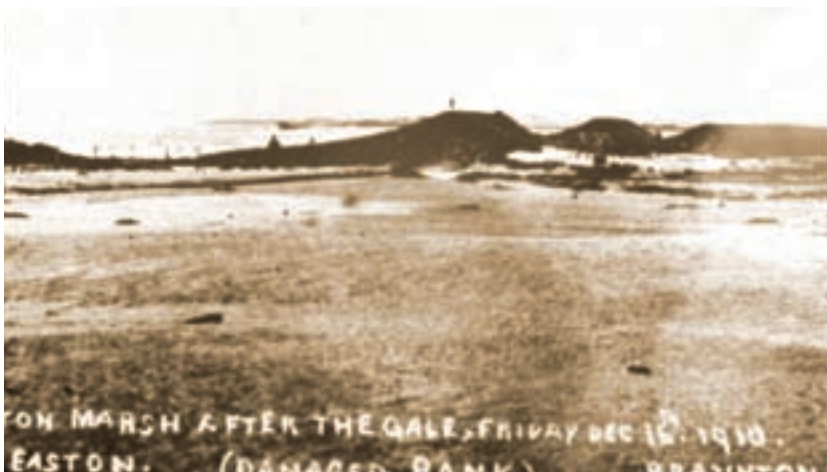
'BRAUNTON MARSH AFTER THE GALE - (DAMAGED BANK)<sup>3</sup>

Regardless of the truth or exaggeration in the North Devon Journal Herald editorial, it is certainly true that the 1910 storm caused extensive damage. Under the conditions set out by the Marsh Inspectors at the time of the second stage of reclamation in the 1850s, the Estate of the late Sir William Williams was now liable for the costs of the repair work, both along the straightened section of the Braunton Pill, and at the Horsey Embankment, where the worst of the breaches appear to have occurred. Three detailed records of the construction and of the schedule of repair works remain; the contract for repairs<sup>1</sup>, the financial statement of repair work<sup>2</sup>, and a final report produced by the engineer in charge, Mr W. T. Douglass<sup>3</sup>. The latter of these reports suggests that the breaching of the Horsey Embankments may have been owed partly to the activities of burrowing rats<sup>3</sup>, which had undermined parts of the banks. Plans indicate the exact size and position of 5 breaches on the Horsey Embankment that were subject to the repair work<sup>4</sup>. The widest and deepest of these breaches was Breach No.1, a gap of 254ft. in length, positioned closest to the White House, with shorter and/or shallower breaches of 160ft., 335ft., 140ft. and 66ft. in length<sup>3,4</sup>. As might be expected, the repair work, which began in the summer of 1911, was not a straightforward affair. The expensive task of repairing the breaches was compounded by the difficulties of tidal scour, which frequently set back the work by further eroding the damaged sections of embankment. The innovative decision to sink derelict barges into some of the breaches was taken, yet reports seem to suggest that this served only to amplify the scouring action of the sea, as it poured around the gaps between the embankment and the barge. Two months after the seven months estimated to complete repairs, the original contractor resigned from the job, and subsequently work was completed under the administration of the Williams' Estate Trustees. The final cost of repairs eventually totalled £19,602<sup>3</sup> (calculated as equivalent to £1,284,715.08 against the 2005 Retail Price Index<sup>5</sup>), with evidence that the final stages of work were still being conducted as late as February 1913<sup>3</sup>. Details of the repair works and the events of the time are provided in Appendix 7.

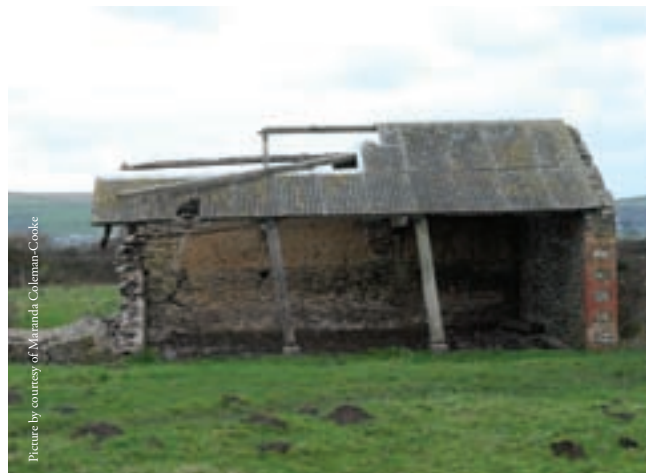
EVEN DURING THE COURSE OF THIS STUDY, MARSH LINHAYS HAVE CONTINUED TO DETERIORATE

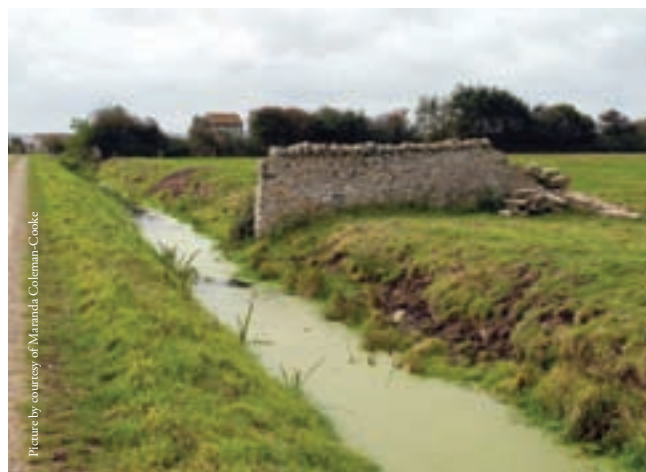
THIS WALL IS NOW ALL THAT REMAINS OF ONE MARSH LINHAY

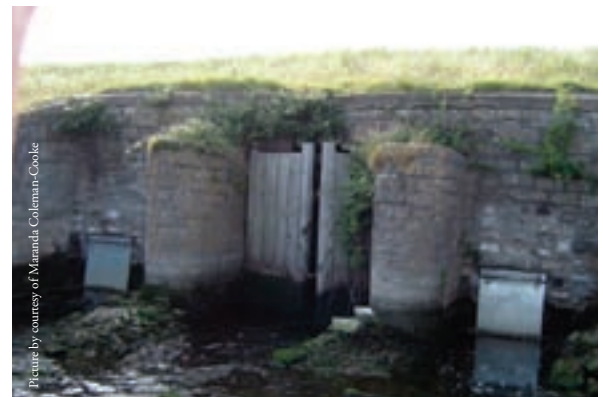
THE GREAT SLUICE

Essentially, the drainage system of Braunton Marsh operates by means of gravity, with the subtle gradients of the clay-lined water channels directing water around the marshes. Water exits the Marshes via the Great Sluice at Horsey Island. During the summer, some water enters the system at Velator, via the River Caen<sup>1</sup>, however the primary source of water entering the system comes from a spring situated in an area known as the 'Meres' or 'Mares' to the north. During the summer of 2006, dry conditions meant that this spring was barely flowing, yet the drains were relatively full, suggesting that the system is also fed by other springs, and from water draining from the Braunton Burrows dune system to the west<sup>2</sup>. Following the re-profiling of the boundary drain by the IDB in the late 1980s, there were concerns that this act may have contributed to a reduction in the water table of Braunton Burrows. This hypothesis was investigated through the preparation of a draft Environment Agency Water Level Management Plan<sup>1</sup>, however results as to the cause of this reduction were inconclusive. Elsewhere, across the estuary, Northam Burrows has also suffered a reduction in its water table in recent years.

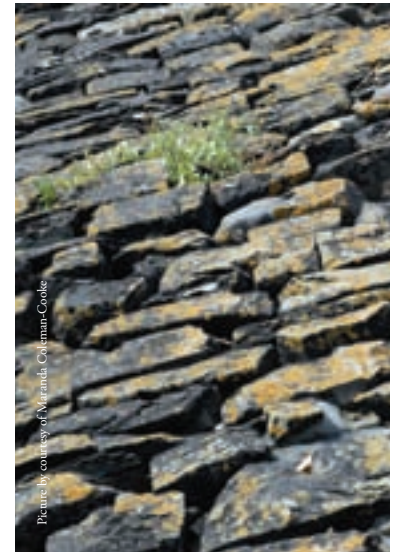
THE EMBANKMENTS WERE ONCE ENTIRELY COVERED BY INTRICATE STONE COBBLES

Whitley's report indicates that the embankment and enclosure of around 200 acres of land at Chivenor were completed in 1856 (Whitley, 1861). This was followed by completion of the works at Wrafton and finally by the enclosure of Horsey Island in 1857 (Whitley, 1861). The embankments were constructed from material dug from the inner ditch. The seaward face of the earthworks was coated with 3ft. of clay into which pitch paving was driven to a depth of between 9 to 12 inches, depending on the exposure to wave action (Whitley, 1861). Having found the local egg-shaped estuary boulders to be inferior, stones from Braunton Quarry were the preferred materials for the pitch paving of the embankments, with a geological structure causing the stone to fracture into wedge-shaped stones, which were easily driven into the clay (Whitley, 1861).

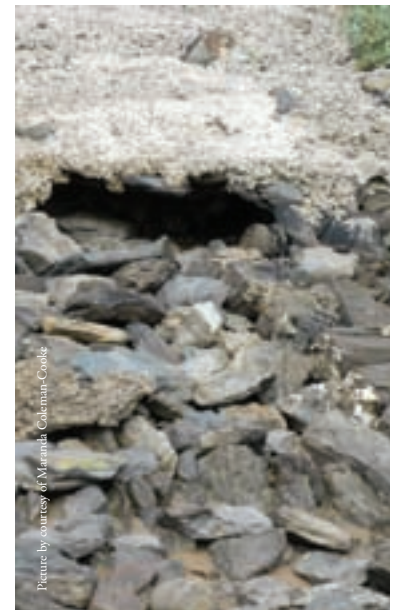
TIDES ERODE BENEATH MODERN CONCRETE REPAIRS

A draft SMP produced in February 1998, suggested that Horsey Island should be deliberately breached, on the grounds that this was the 'only viable long-term option on economic grounds'. As Horsey Island is already an important area for over-wintering birds, the investigation of a retreat option was supported by the RSPB. However the historical significance of the area and the existing resistance capabilities of the Great Bank, which would then become the main sea defence protecting the Marshes and the Great Field, were highlighted by the Braunton Marsh IDB. The original stone facing, which reinforced this Great Bank, was removed following the reclamation of Horsey Island (Appendix 6), and as such, the embankment is now comprised of little more than soil and clay. The SMP pointed out that a far more detailed examination of the technical, economic and environmental implications of breaching the Horsey Island Embankment would be necessary. The final version of the SMP<sup>2</sup> eventually recommended that the cobbled Horsey Embankment should be observed and monitored.

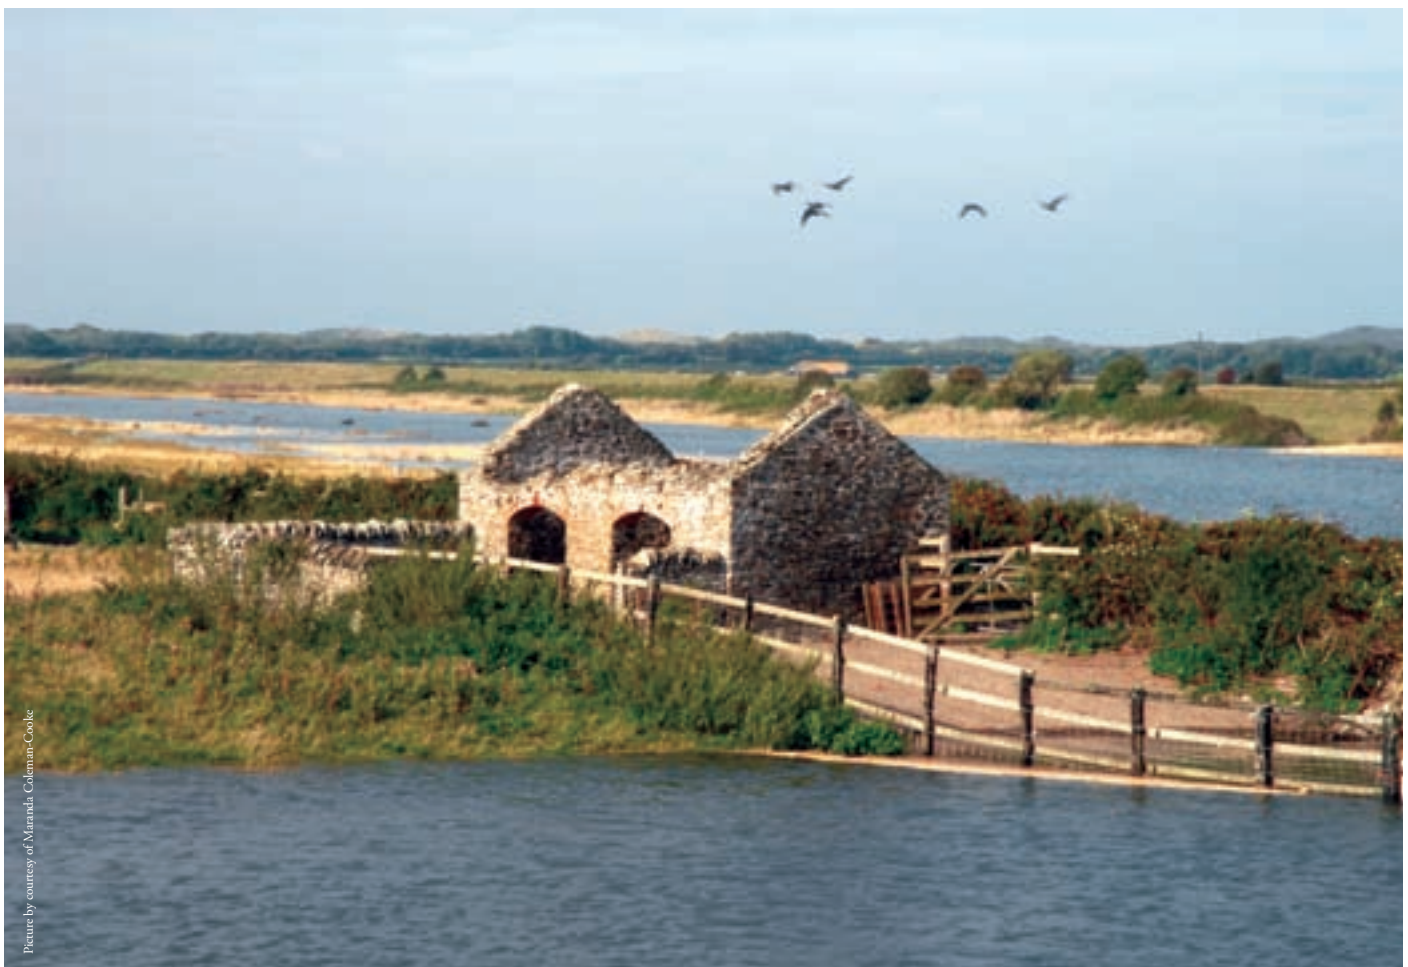
FLOODING OF HORSEY ISLAND DURING SEPTEMBER SPRING TIDES, 2006
