North Devon Focus Area Estuary Pollution Project Report

2017/2018

To review the North Devon Focus Area Estuary Pollution Project, which seeks to reduce diffuse pollution arising from agricultural practices within the River Caen Catchment.

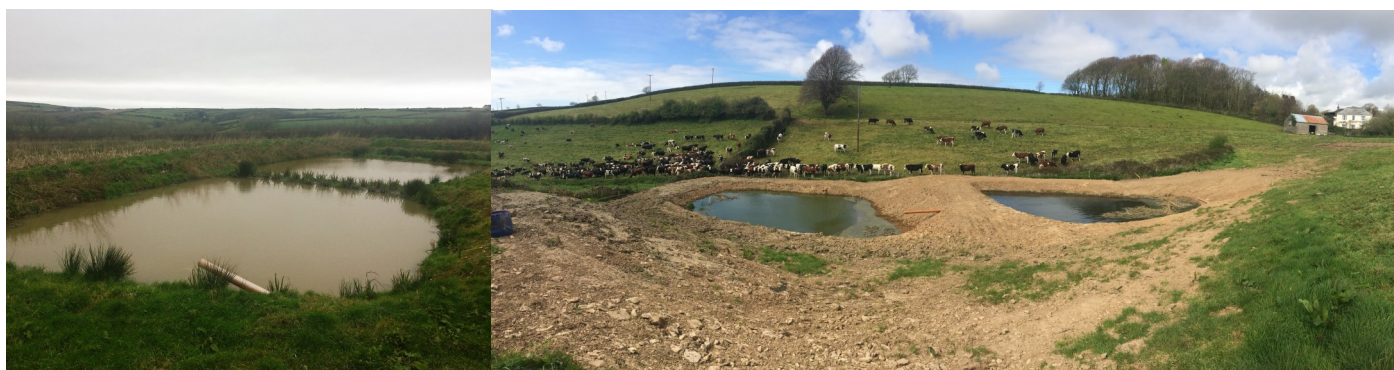
The diversion of clean roof waters away from yard contaminates can be beneficial for both the landowner and the environment, as less muck spreading is required, inevitably leading to less pollutant loaded run-off entering the watercourse. Otherwise, these dirty waters are likely to contaminate clean roof waters and require containment within a slurry store. This avoidable storage subsequently reduces the capacity for solely yard concentrated waters. Post separation, lightly fouled waters can be cleaned through the construction of baffle ditches, constructed wetlands or sedimentation ponds, see below.

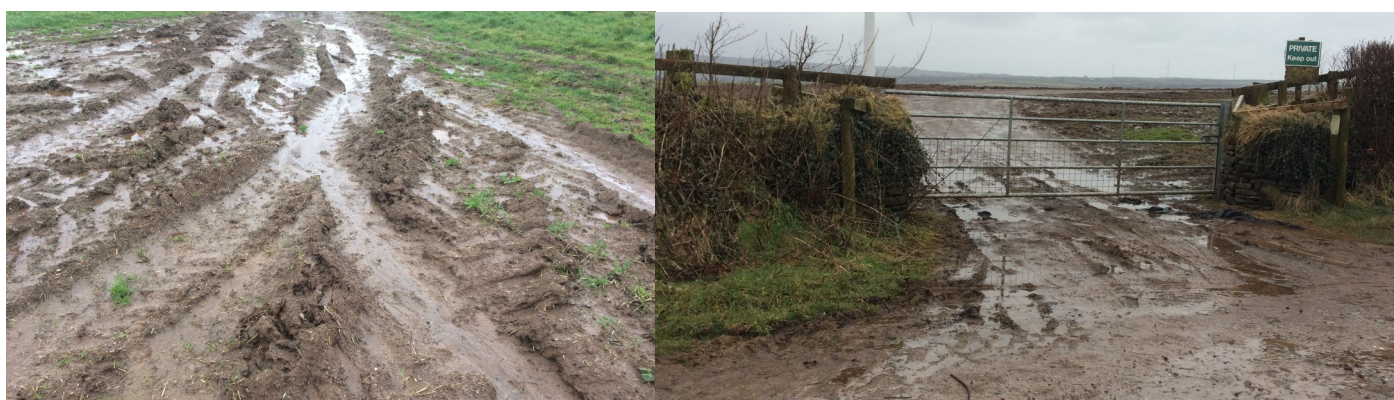
These artificially created soils can be eroded by several processes including sheet wash, rill, or in extreme cases, gully erosion. Particularly in times of heavy rainfall, these processes mobilise the topsoil and additional slurry which has been spread on to the surface. If the ground is also compacted during rainfall, run-off will transport these excess nutrients into the river at a faster rate, due to the lower infiltration capacity of the soil to receive the waters. Infiltration capacity is typically at its lowest at headlands and at field gateways. This is where agricultural traffic is concentrated, whether it is to harvest cereal crops or to enter to feed livestock (see above).

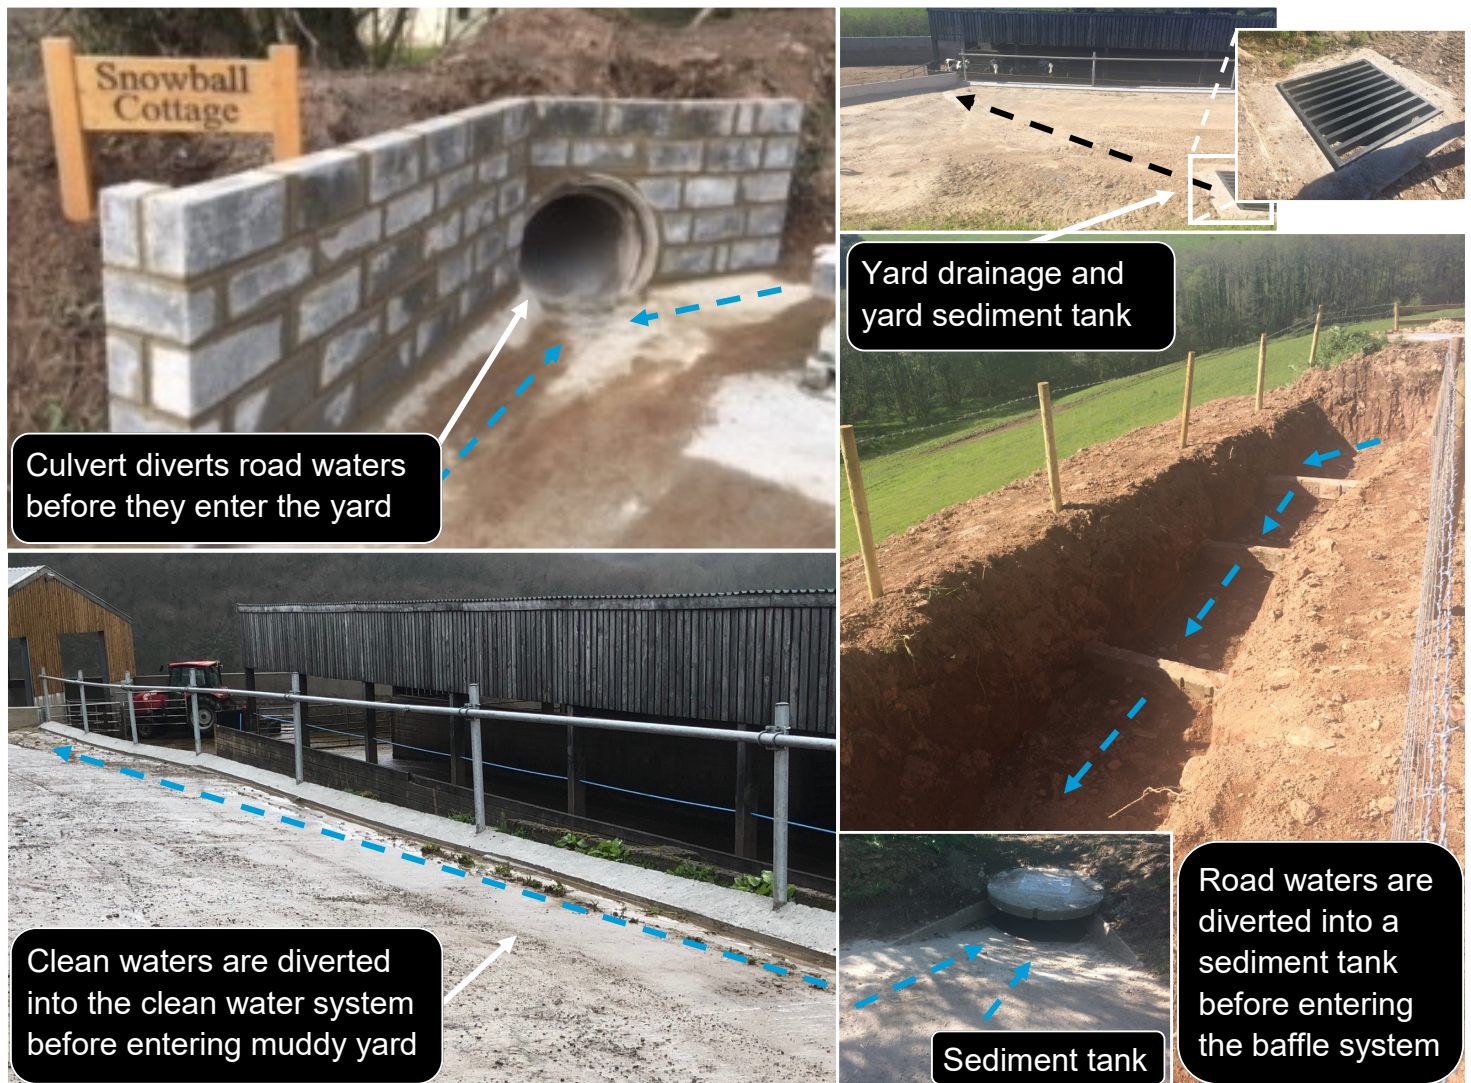
Figure 9. Farm A after photos.

All yard clean and dirty water separated

Significantly reduced yard flooding and the transport of pollutants

Re-established original functioning of sediment pond system

All channels of road waters diverted away from the cow shed and treated before entering the watercourse

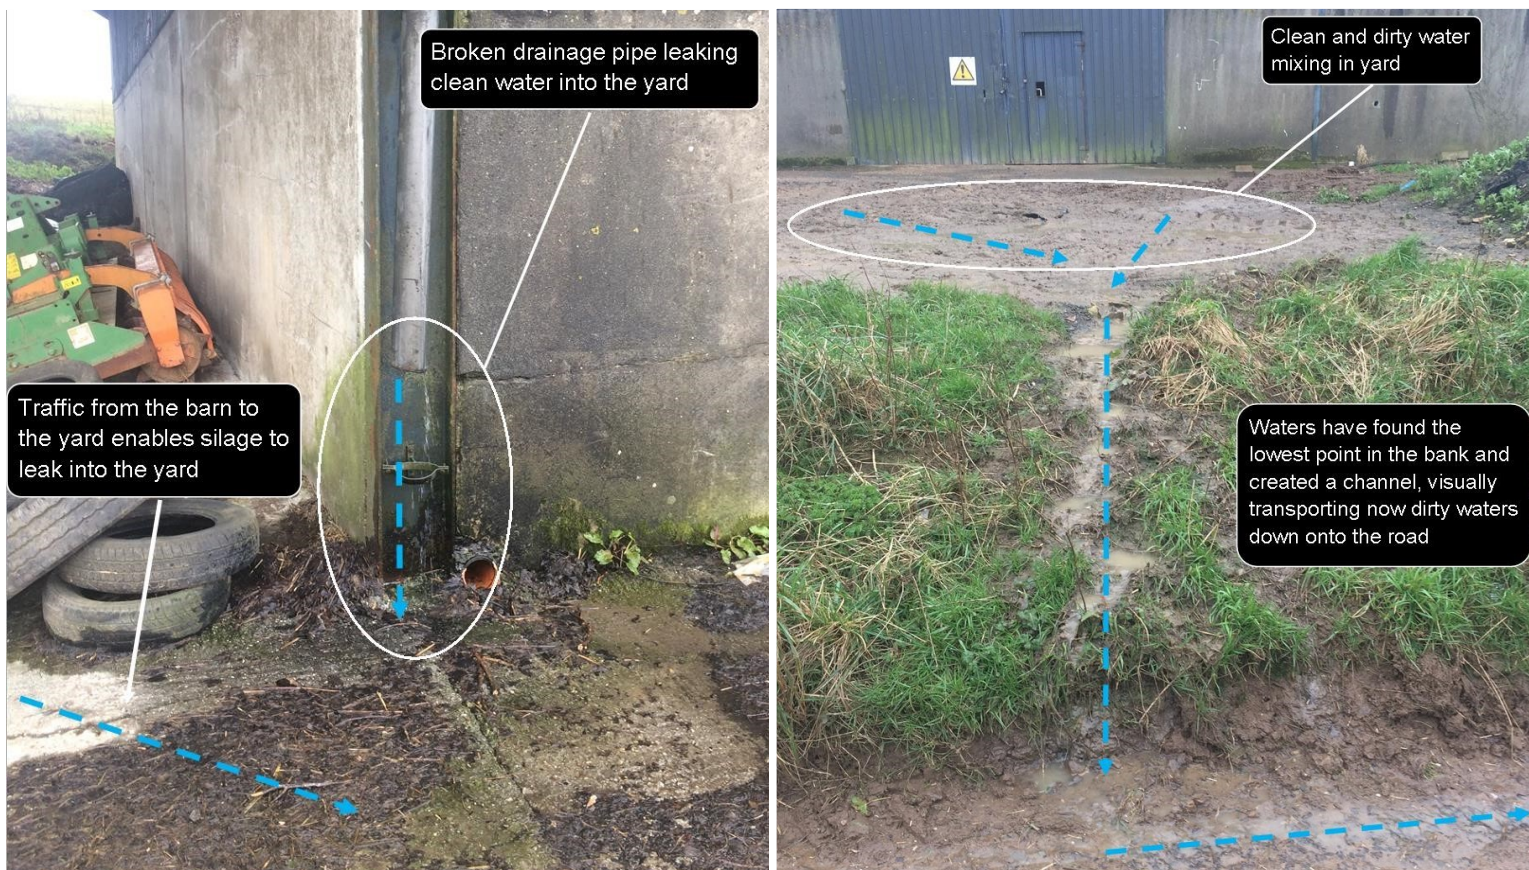
Figure 10. Issues 1 & 2 - Rainwaters mixing with dirty yard waters and allowed to head unmanaged towards the watercourse.

Rainwater from roof buildings are contaminated by sediment loaded yard waters and pollutants.

Untreated lightly fouled yard waters and dirty track waters allowed to head towards the watercourse unmanaged.

Code	Project Design
RW1	Replace broken downpipes into under yard drainage.
YRD	Install two sediment tanks. One located in the yard and one adjacent to the field track to catch and treat respective waters.
CY4	Lay remaining section of concrete yard with shallow humps to retain and prevent water contamination.
FC5	Excavate soil profile pits to assess level of compaction and soil aeration.

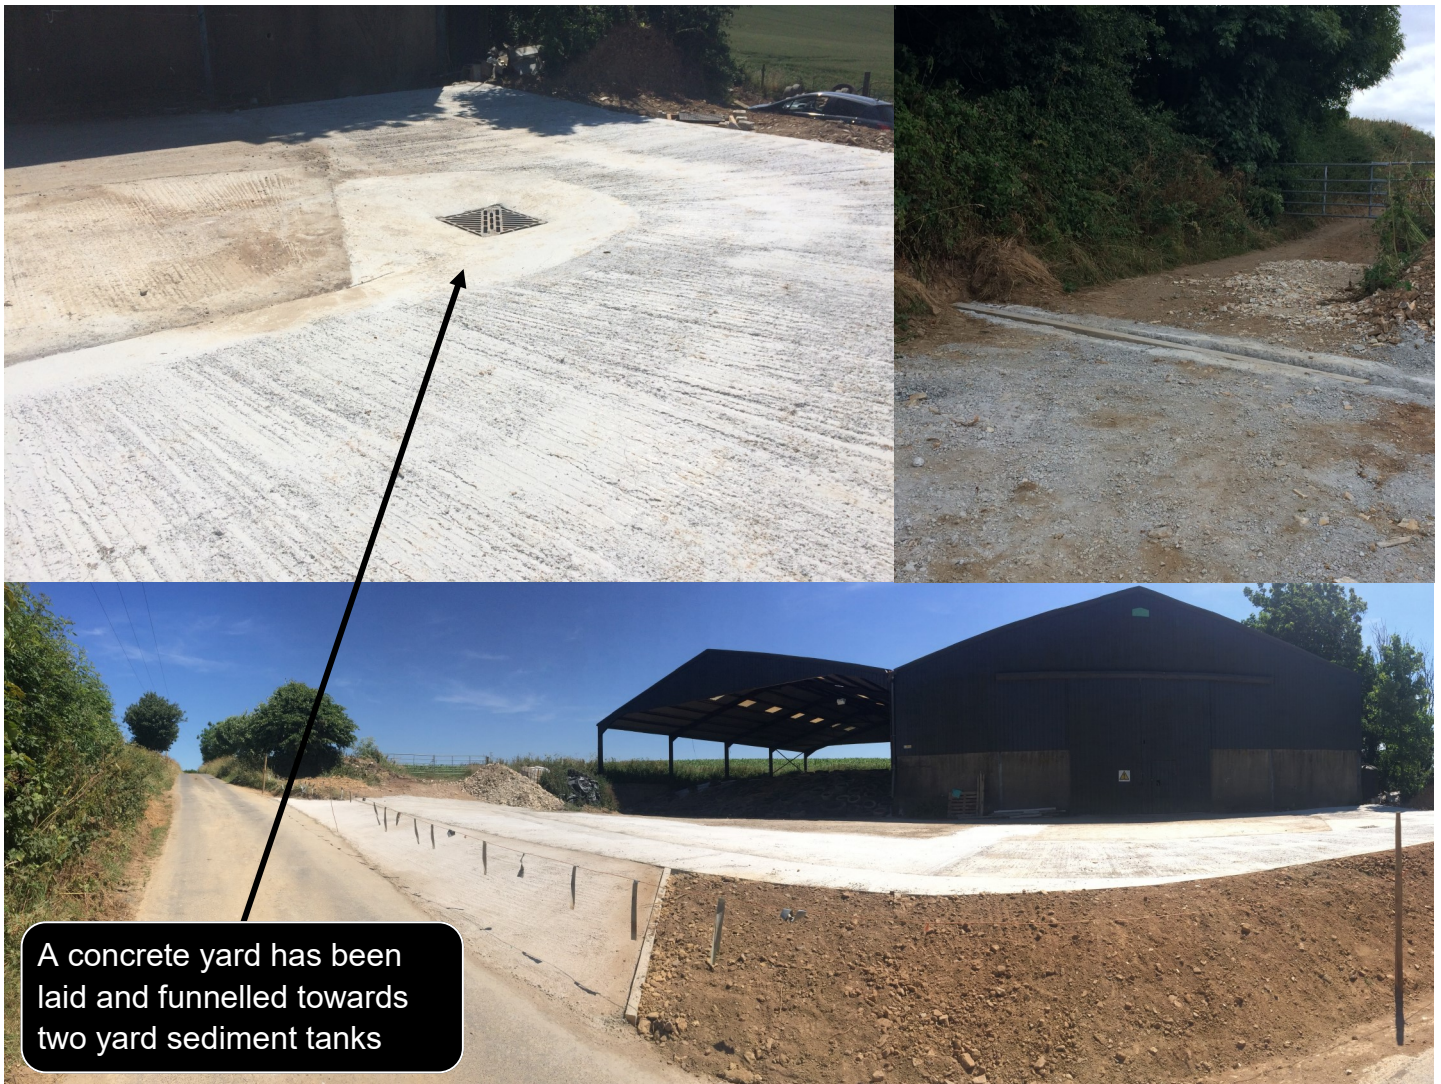
Figure 12. Farm B after photos.

Prevented rainwater contamination by sediment loaded yard waters.

Manage, separate and clean yard and track sediment loaded run-off before entering watercourse - to be completed in the projects second year.

Well maintained and clean yard, preventing soil heave and pollution entering the highway.

Reduced in field compaction to allow waters to filtrate into the soil, preventing soil and nutrient loss.

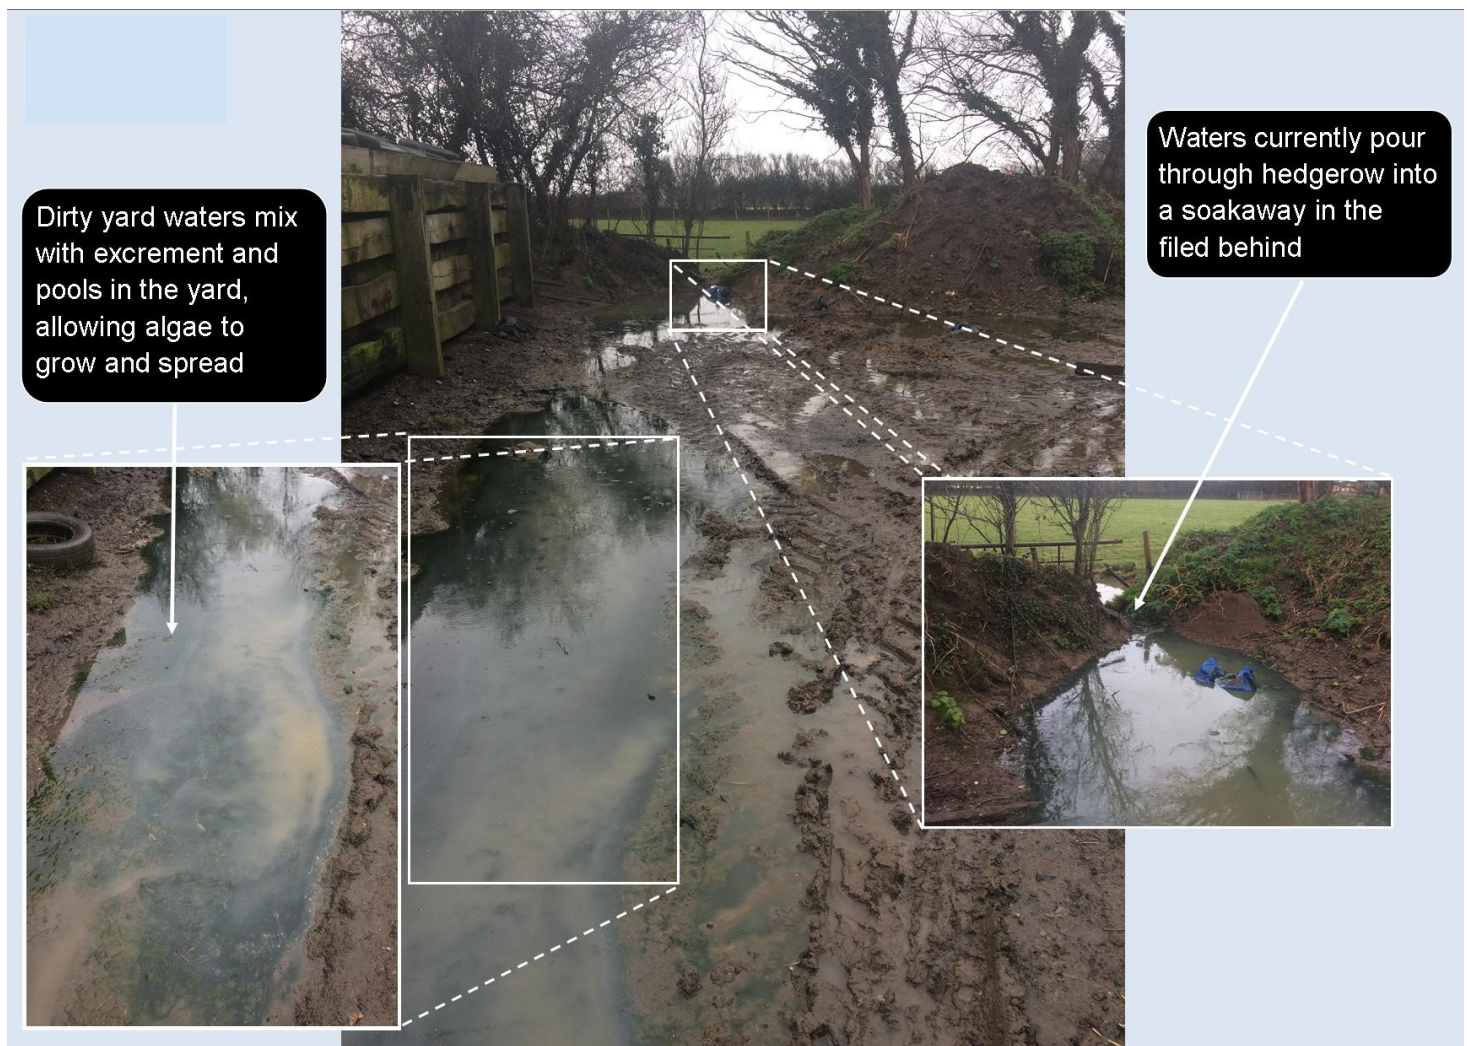
Figure 13. Issue 2 - pollutants and sediment loaded run-off allowed to mix and head unmanaged towards the watercourse.

In yard soil heave causing pollutant and sediment loaded run-off to mobilise and be transported into the watercourse.

Code	Project Design
DW1	Fence off stream from cattle and install drinking troughs and a solar panel pump.
CY2	Lay remaining section of concrete yard with shallow humps to retain and prevent water contamination.
ST3	Install two open sediment tanks, fenced with gated access. The first located in the front yard and the second adjacent to the hedgerow to treat respective waters.

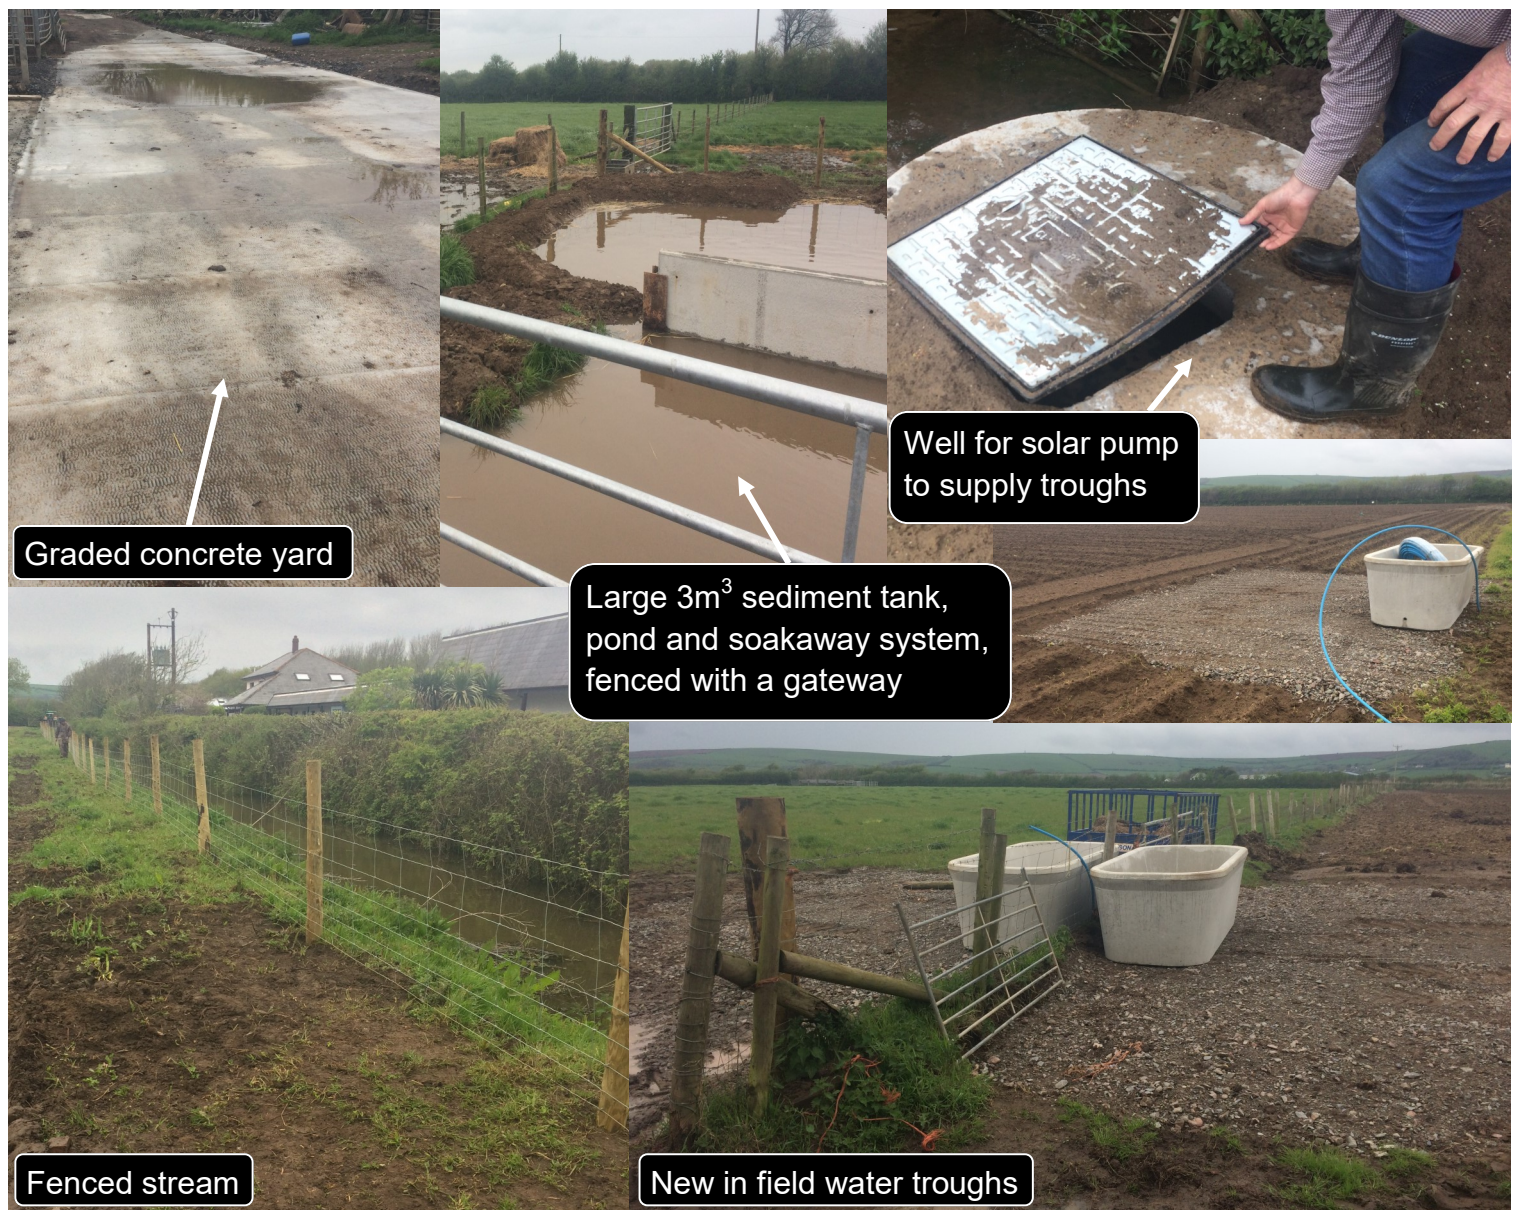
Figure 15. After photos of the works at Farm C.

Fenced off watercourse at three points and alternative drinking access for cattle.

Well maintained and clean yard, preventing pollutant loaded run-off getting to the watercourse.

Manage, separate and clean yard and track sediment loaded run-off before entering watercourse.

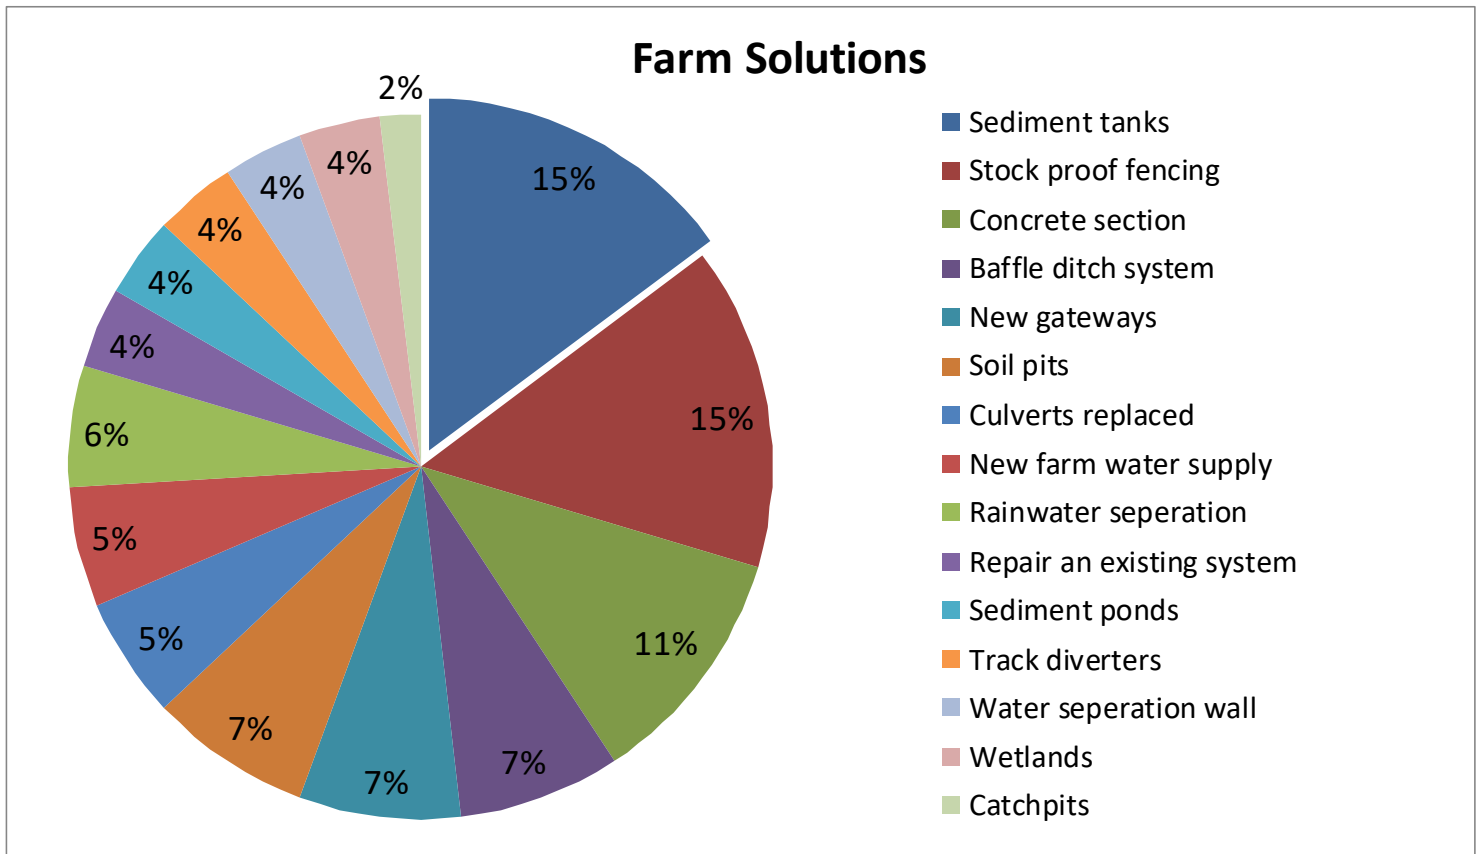
Figure 17. Farmyard solutions summary.

As the above chart shows, there were a variety of solutions adopted to suit the individual landowners requirements. Sediment tanks and stock proof fencing were the interventions taken up by most landowners, whereas catchpits were only adopted at one location. Sediment tanks were found to suit the majority of landowners as they can be discrete within the farm yard. As well as being discrete, they are highly affective at cleaning yard waters and settling out sediment from the water column. Fencing was constructed a lot within the project as it serves several useful purposes including protecting watercourses, wetland ponds and baffle ditches. Catchpits however are a much more bespoke intervention and was adopted in this instance as the landowner was experiencing severe river bed erosion from the outflow of their settlement pond.

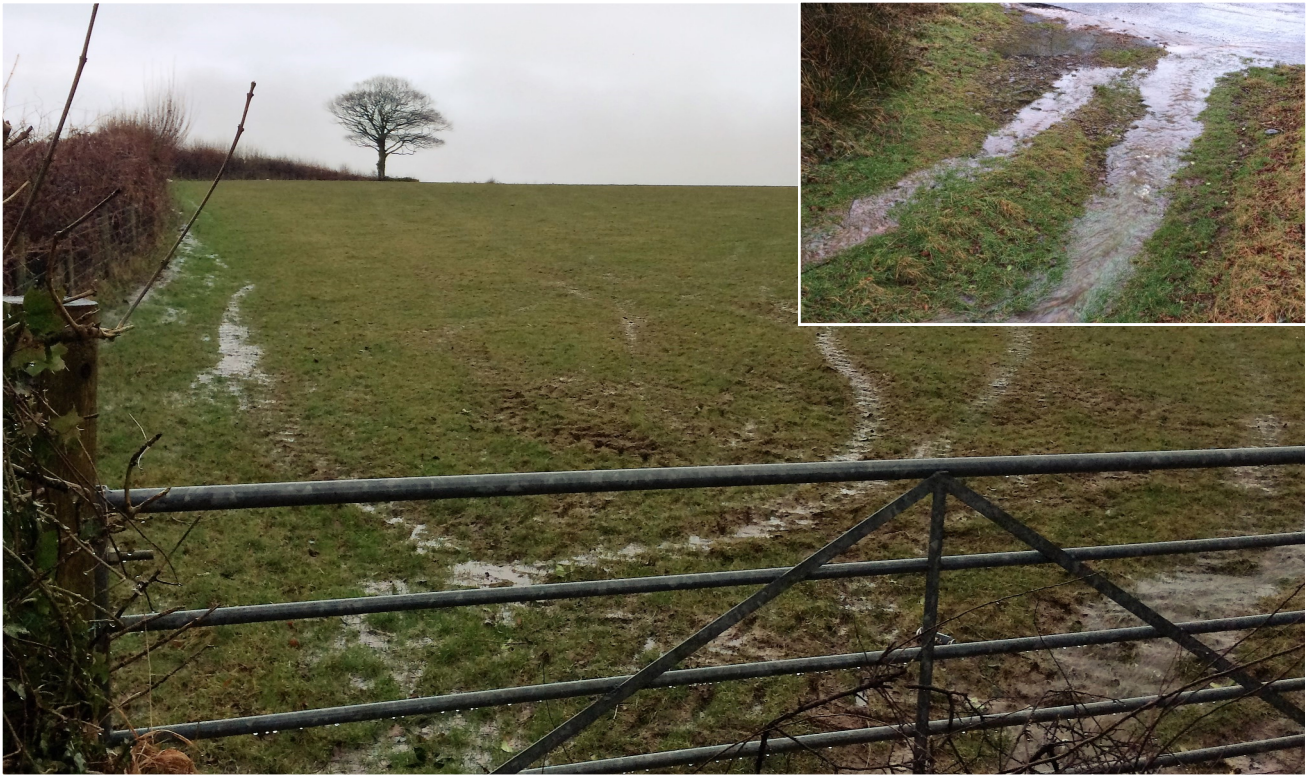
Figure 18. Tightly grazed fields in the Bradiford Catchment. Inset: water streaming out of the same gateway (Source: Phil Metcalfe).

The current management which caused the most soil and run-off issues was found to be gateways and associated traffic. Poorly located gateways were found to majorly affect both in-field soil degradation and also the transportation of loose soils out on to the highway. As regular agricultural traffic enters and leaves the gateways, whether it is to feed livestock, sow or harvest crops, this concentrated compaction from large machinery reduces infiltration capacity and soil health. We also found that gateways and particular tracks were used more often due to farmers storing farmyard manure in fields as part of agricultural practice. As machinery entered and left the gateways wheel ruts were created, in some cases approximately 2ft deep. These ruts were found to act as conduits in times of heavy rain, mobilising sediment and nutrient loaded waters on to the highway and towards the watercourse. Further, headlands also experienced vast machinery traffic, similar to gateways, and therefore contribute to wider in-field soil degradation.
