## **Taw Torridge Coastal Management Study:**

**Review of erosion adjacent to Northam Burrows  
landfill and recommendations for remedial action**

January 2013

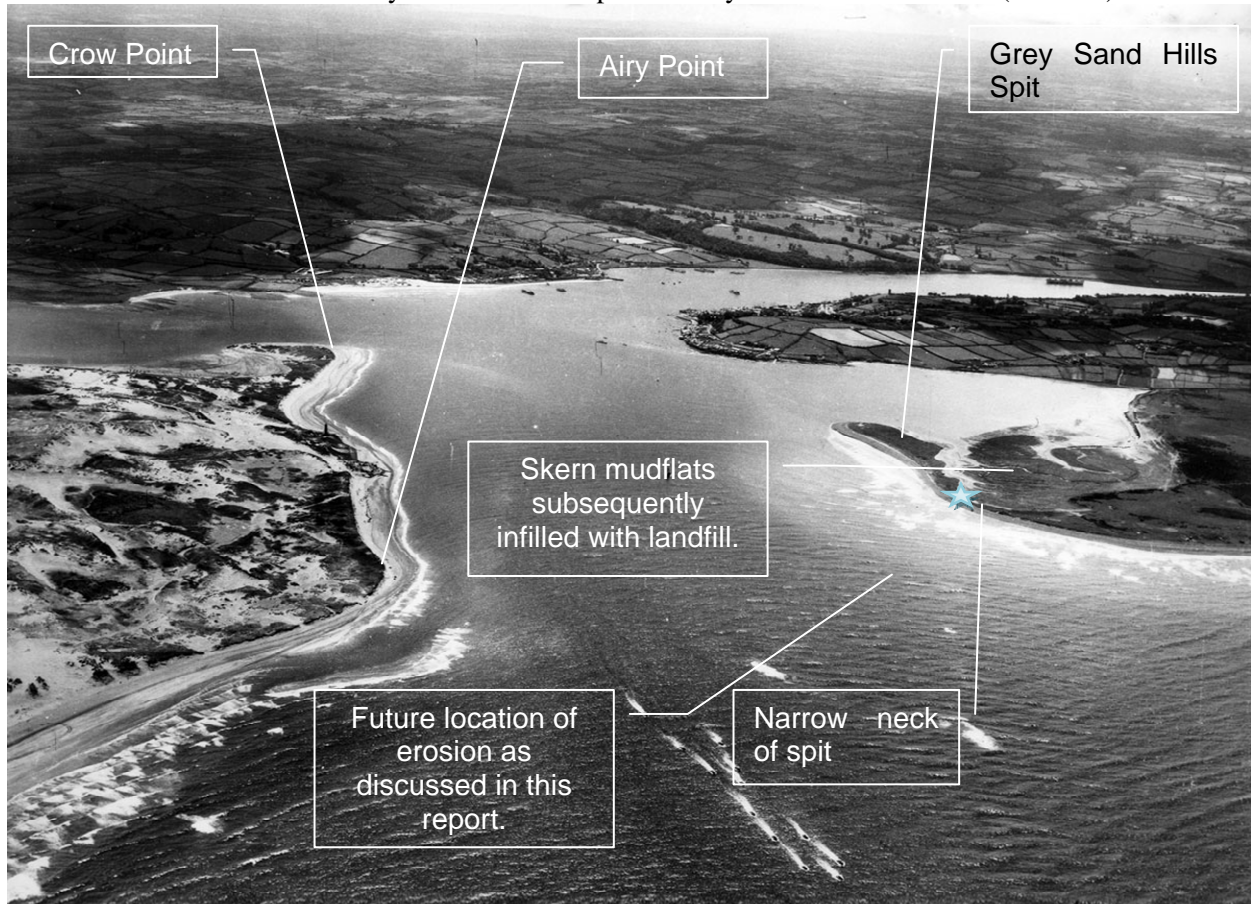
The study area is located on the south bank of the outer Taw estuary in North Devon at the northern extremity of the Northam Burrows in an area known as Grey Sand Hills. The Grey Sand Hills form an eastward facing spit in the Taw Torridge estuary as shown in Figure 2-1. The south side of the Grey Sand Hills spit was originally an area of mudflat and saltmarsh as shown on Figure 2-1, an aerial photograph of this area dated 1947. This clearly shows that the spit was very narrow at its western (seaward) end.

*Figure 2-1 Aerial view of the mouth of the Taw Estuary in 1947 from the northwest*

The Northam Burrows landfill was formed between 1937 and 2004. The various phases of its development are shown on Figure 2-4. The northern boundary of the landfill is very close to the Taw Estuary for some of its length, probably close to the area shown on Figure 2-1 where the Grey Sand Hills spit is very narrow.

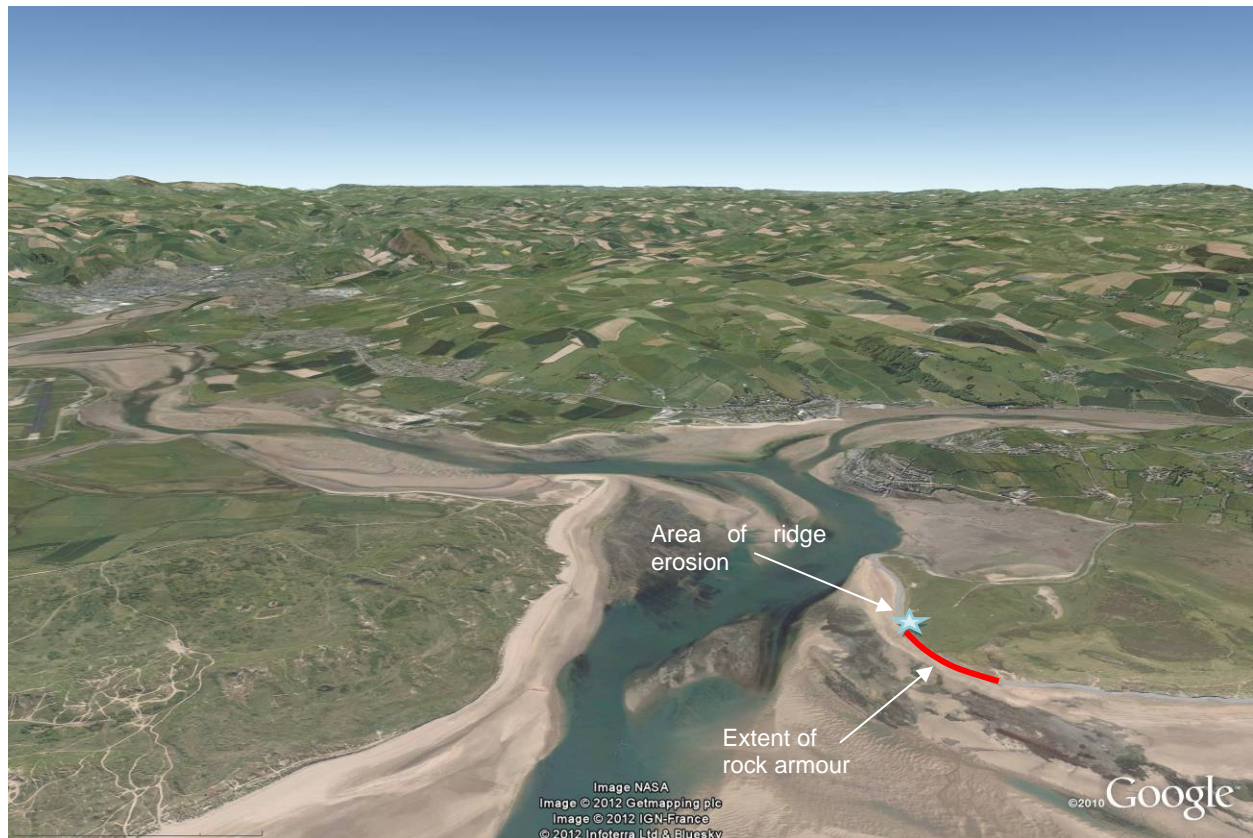
The Skern area of mudflat and saltmarsh south of the Grey Sand Hills was progressively filled with landfill between the 1960s and 1994 when the site was closed. An aerial photograph of the study area in 2009 from Google Maps is shown on Figure 2-2, which also shows the location where the recent erosion which is the subject of this report is located.

*Figure 2-2 Aerial view of the Grey Sand Hills in 2009*

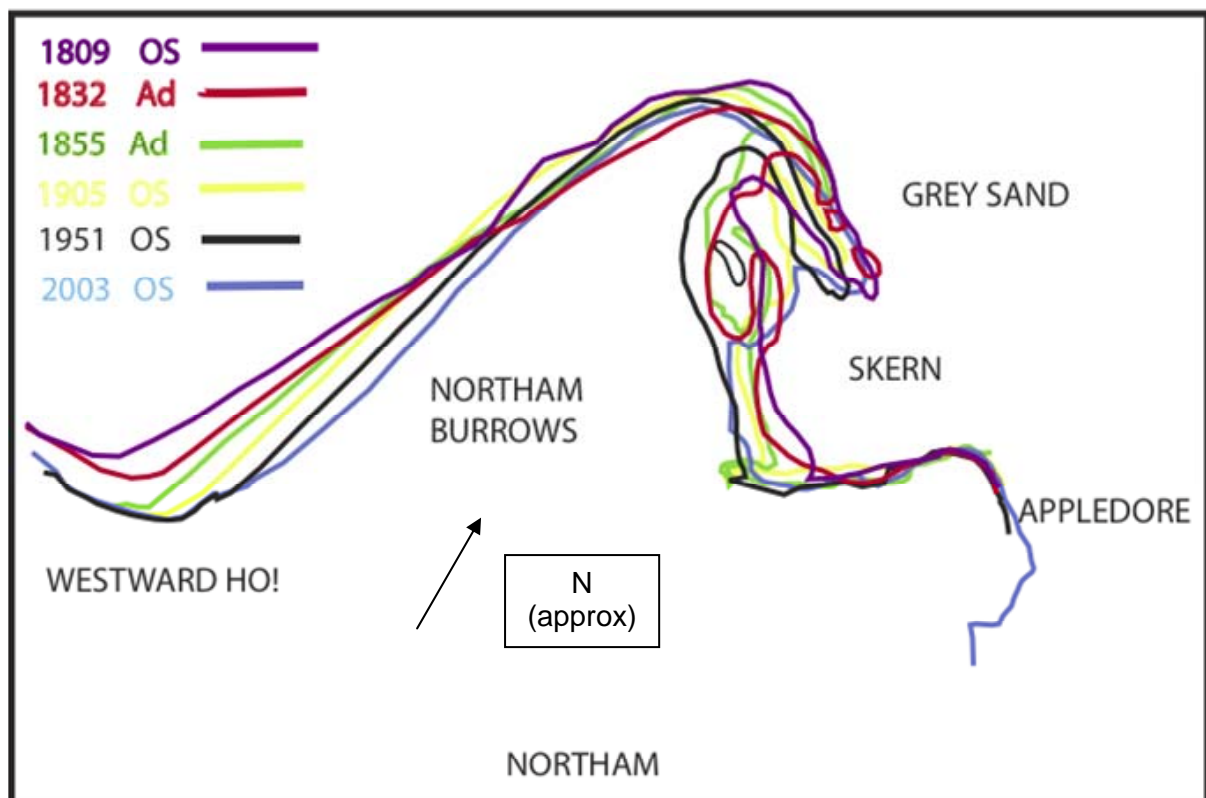
Keene (2008) has considered the changes in the shape of the Northam Burrows and Grey Sand Hills in his geomorphology of the North Devon coast presentation. He compared the outline of the Northam Burrows on Ordnance Survey maps from 1809 to 2003 as shown in Figure 3-1. All these Ordnance Survey maps show the spit at the northern limit of the Northam Burrows. In all the historic maps the orientation and plan shape of the spit is generally similar though the location of the northern boundary between the spit and the Taw Estuary and its eastward extent do vary. The maps from the surveys prior to 1951 show the natural evolution of the spit over 140 years before substantial landfilling of the intertidal area south of the spit began. The final outline, from 2003, excludes the area infilled by the landfill as it is no longer intertidal.

From Keene 2008

Figure 3-1 Changes in Northam Burrows outline 1809-2003

The mapping of Figure 3-1 suggests that the northern extent of the Northam Burrows has consistently retreated over the past two centuries. The 1809 map shows the Northam Burrows extending furthest

north. The 2003 map shows this northern limit of the Northam Burrows to have retreated by about 200m since 1809. This finding is slightly concealed because of a marked 12° counter-clockwise rotation in the alignment of the northern side of the spit between 1951 and 2003. This has had the effect of bringing the eastern end of the spit almost back to its 1809 position from the more southerly location in 1905 and 1951.

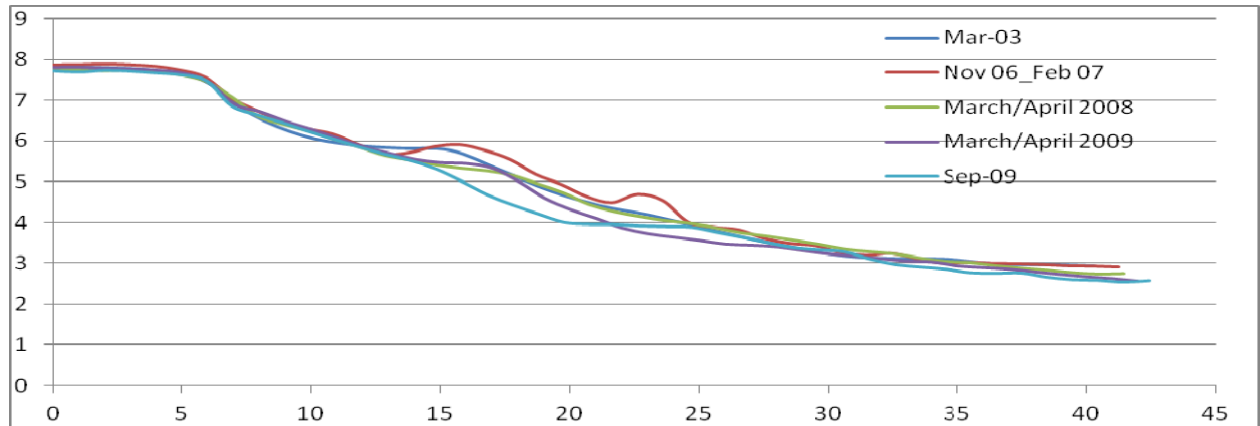
However, by using intermediate surveys to draw cross sections of the coastline at the site of the recent erosion in Figure 3-3, further detail on the recent changes can be revealed. The key point to note is that the majority of the changes have occurred around a level of +5mAOD. This is above the level of mean high water springs (3.9mAOD at Clovelly), which indicates the erosion is largely due to wave action during high tides rather than tidal flow.

Figure 3-3 Cross section showing changes from 2003 to 2009 at the site of the recent erosion

Figure 3-3 indicates that considerable amounts of erosion have occurred between 3.5 to 6mAOD but the profile below 3mAOD appears to be stable. Waves can only reach the eroding slope on a high tide, and consequently wave heights will be depth limited. The outline design wave climate is shown in Table 5-2 below, together with associated water level.

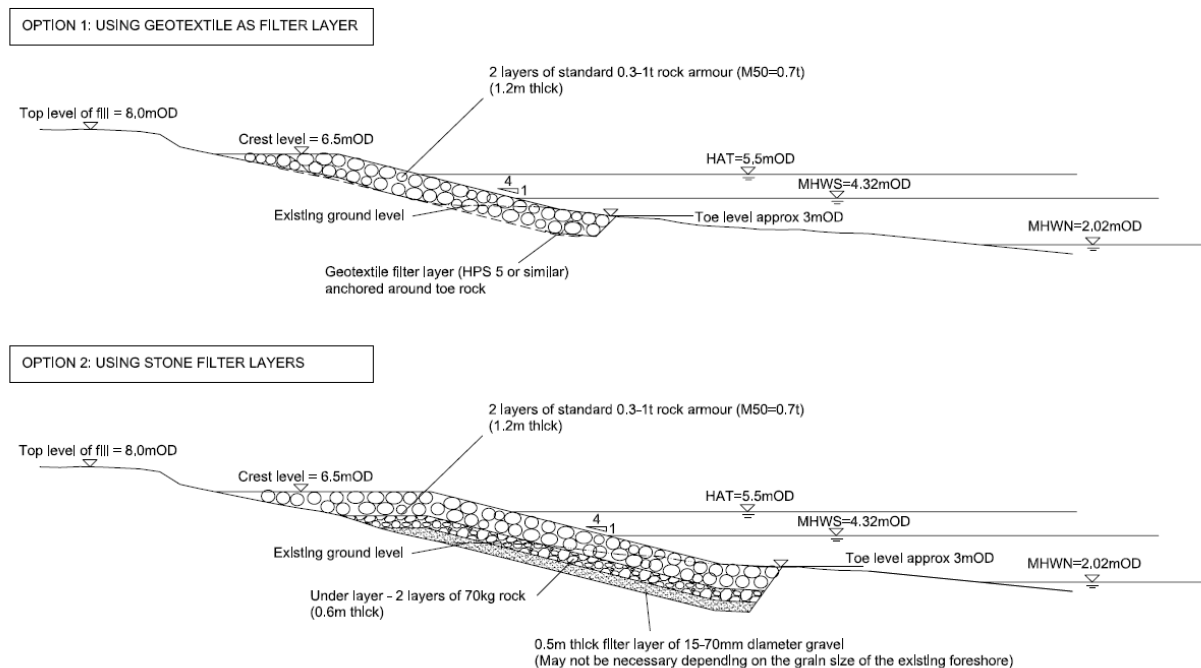
Figure 5-1 shows indicative cross sections of the two options. Detailed design of the armour will need to take into account the slope of the foreshore, and it will need to tie into the existing armour at the west end (details of which, such as crest and toe levels, are presently unknown). The cross sections are based on the most up to date survey information of the area from September 2009, but it is possible that the existing foreshore is significantly different from that shown here (note these do not represent any works undertaken after September 2012).

*Figure 5-1 Indicative rock armour sections*

The crest level of 6.5mOD gives a 1m freeboard above highest astronomical tide, and the toe level of 3mOD means that the protection extends below the level that is currently experiencing erosion. The dug in toe shown on both options will allow the foreshore level to drop to some extent (approximately 0.5m) without the revetment being undermined, but if long term monitoring shows that the level is dropping more than expected, then additional rock may be needed at the toe.

The slope as shown on the figures is 1 in 4. The design however has been carried out on the basis of a 1 in 3 slope, as it may be that the existing slope differs to that shown on this section and designing for a steeper slope is more conservative.

A high level costs estimate for the profiles shown in Figure 5-1 are shown in the table below for 60m (approx 2,100tonnes) and 100m (approx 3,500 tonnes) length. This shows that the option without the geotextile is considerably more expensive, but it is thought that the costs for stone under layers could be significantly reduced if a suitable local supply of material was available (such as material already on the foreshore).

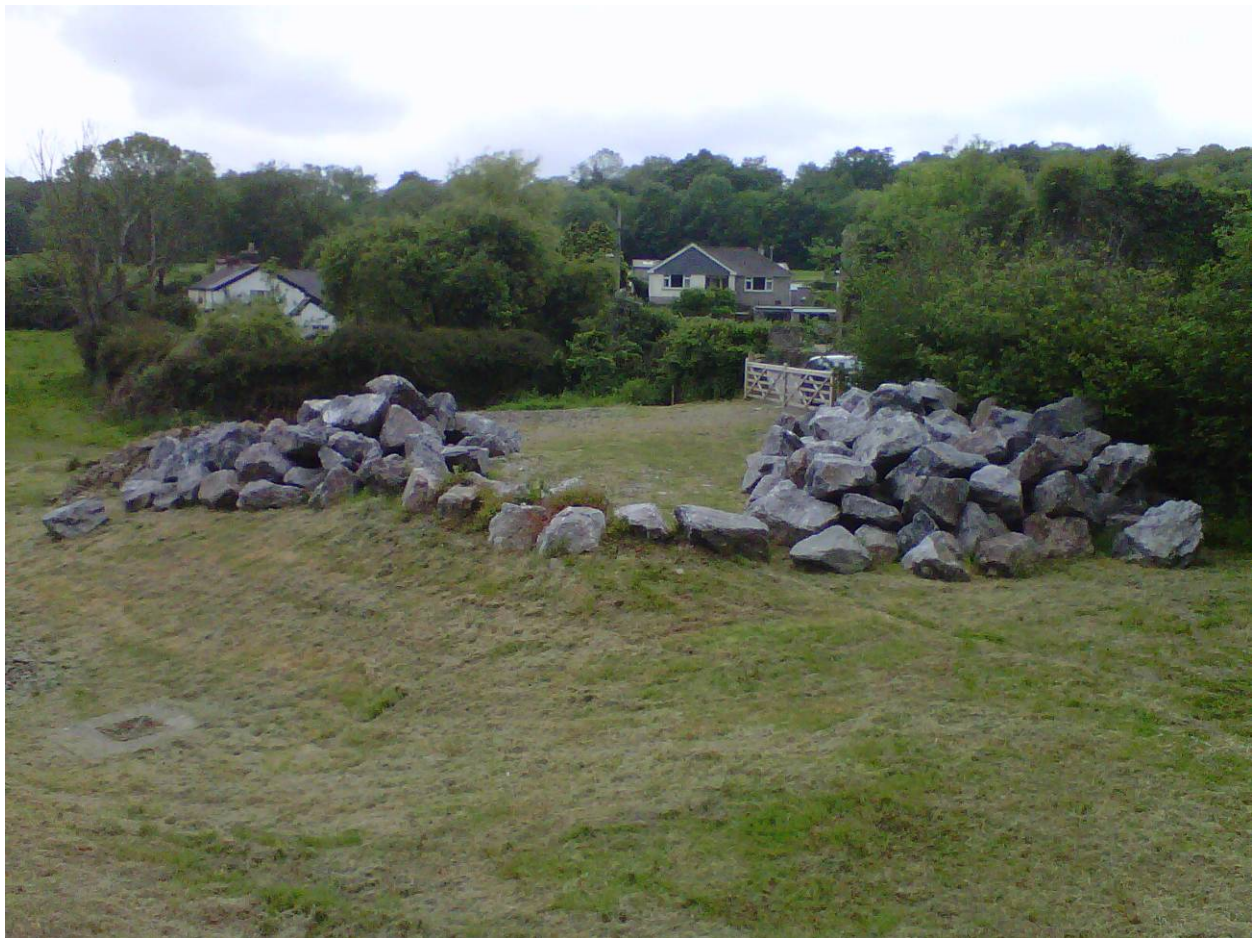
There is a potential supply of rock armour stored at Annery Kiln. This is described as around 150 tonnes of rock of 0.75 to 1 tonne blockstone. This blockstone is illustrated in Figure 5-1. The properties of this rock have not been determined, but the sizing calculations show that the weight of the rocks would be sufficient for use. However the cross section shown in Figure 5-1 required approximately 35t of rock per metre length of revetment, and therefore there would only be enough rock here to provide around four to five metres of protection, which is not adequate for this purpose.

*Figure 5-2 Blockstone at Annery Kiln*
