Natural Flood Management at Higher Boode Farm, Braunton

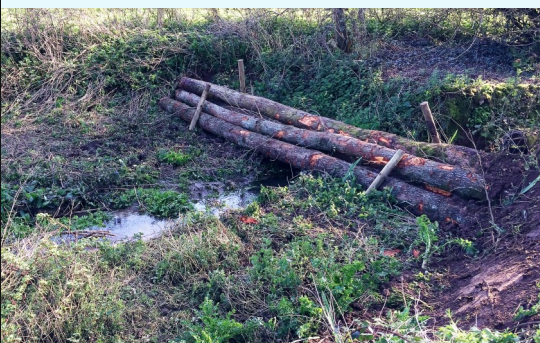
Log dams act as physical instream barriers to high river flows, causing flood waters to leave the channel and breach on to the floodplain. When these events occur waters are slowed down as roughness has increased and therefore have the opportunity to infiltrate into the floodplain. As these waters are infiltrated into the floodplain, this increases the time taken for these potential flood waters to reach downstream communities, thus reducing the flood peak and associated devastation. This intervention also improves water quality; when river flow is reduced, sediment in the water column is able to be released and deposited. The dams were installed by a local contractor, see below.

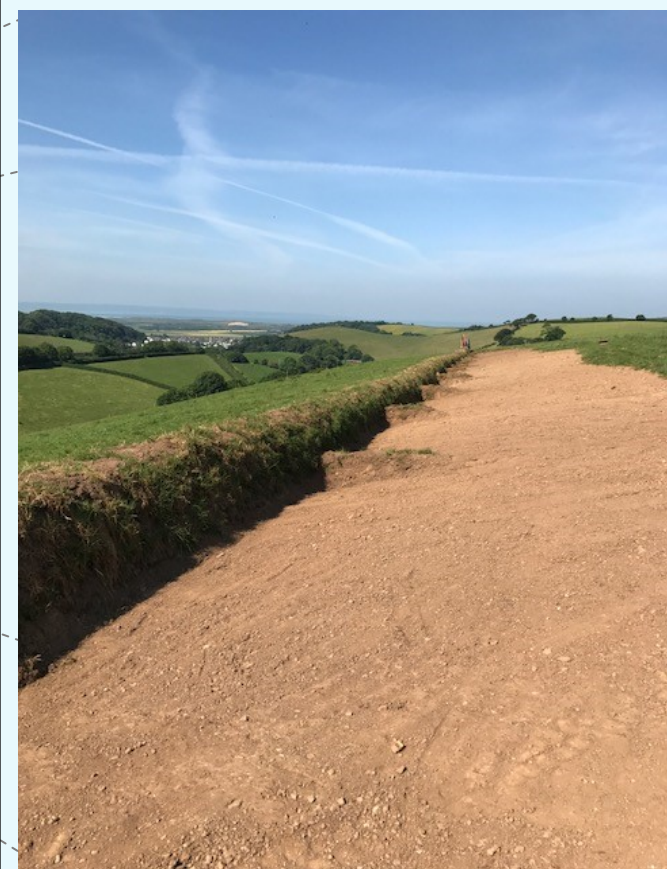
Hedgerow Specification

Hedgerows act as a physical land barrier to runoff accumulation and were designed to withstand a 1 in 100 year rainfall event. The banks featured small baffles and overflow pipes. The baffles reduced the possibility for the bank to act as a conduit for water flow and, in times of heavy rain, improve water quality as small pools behind the baffles facilitate UV penetration and the breakdown of bacteria. The overflow pipes were positioned alongside the baffles thus receiving any excess flows and reducing the likelihood of bank hydraulic failure.
